**2018 ANNUAL INSPECTION REPORT  
RANGE ROAD LANDFILL  
ASH DISPOSAL FACILITY**

**China Township, St. Clair County, Michigan**

January 2019

**APPENDIX B**  
**DTE Range Road Landfill Annual Inspection 29 March 2018**

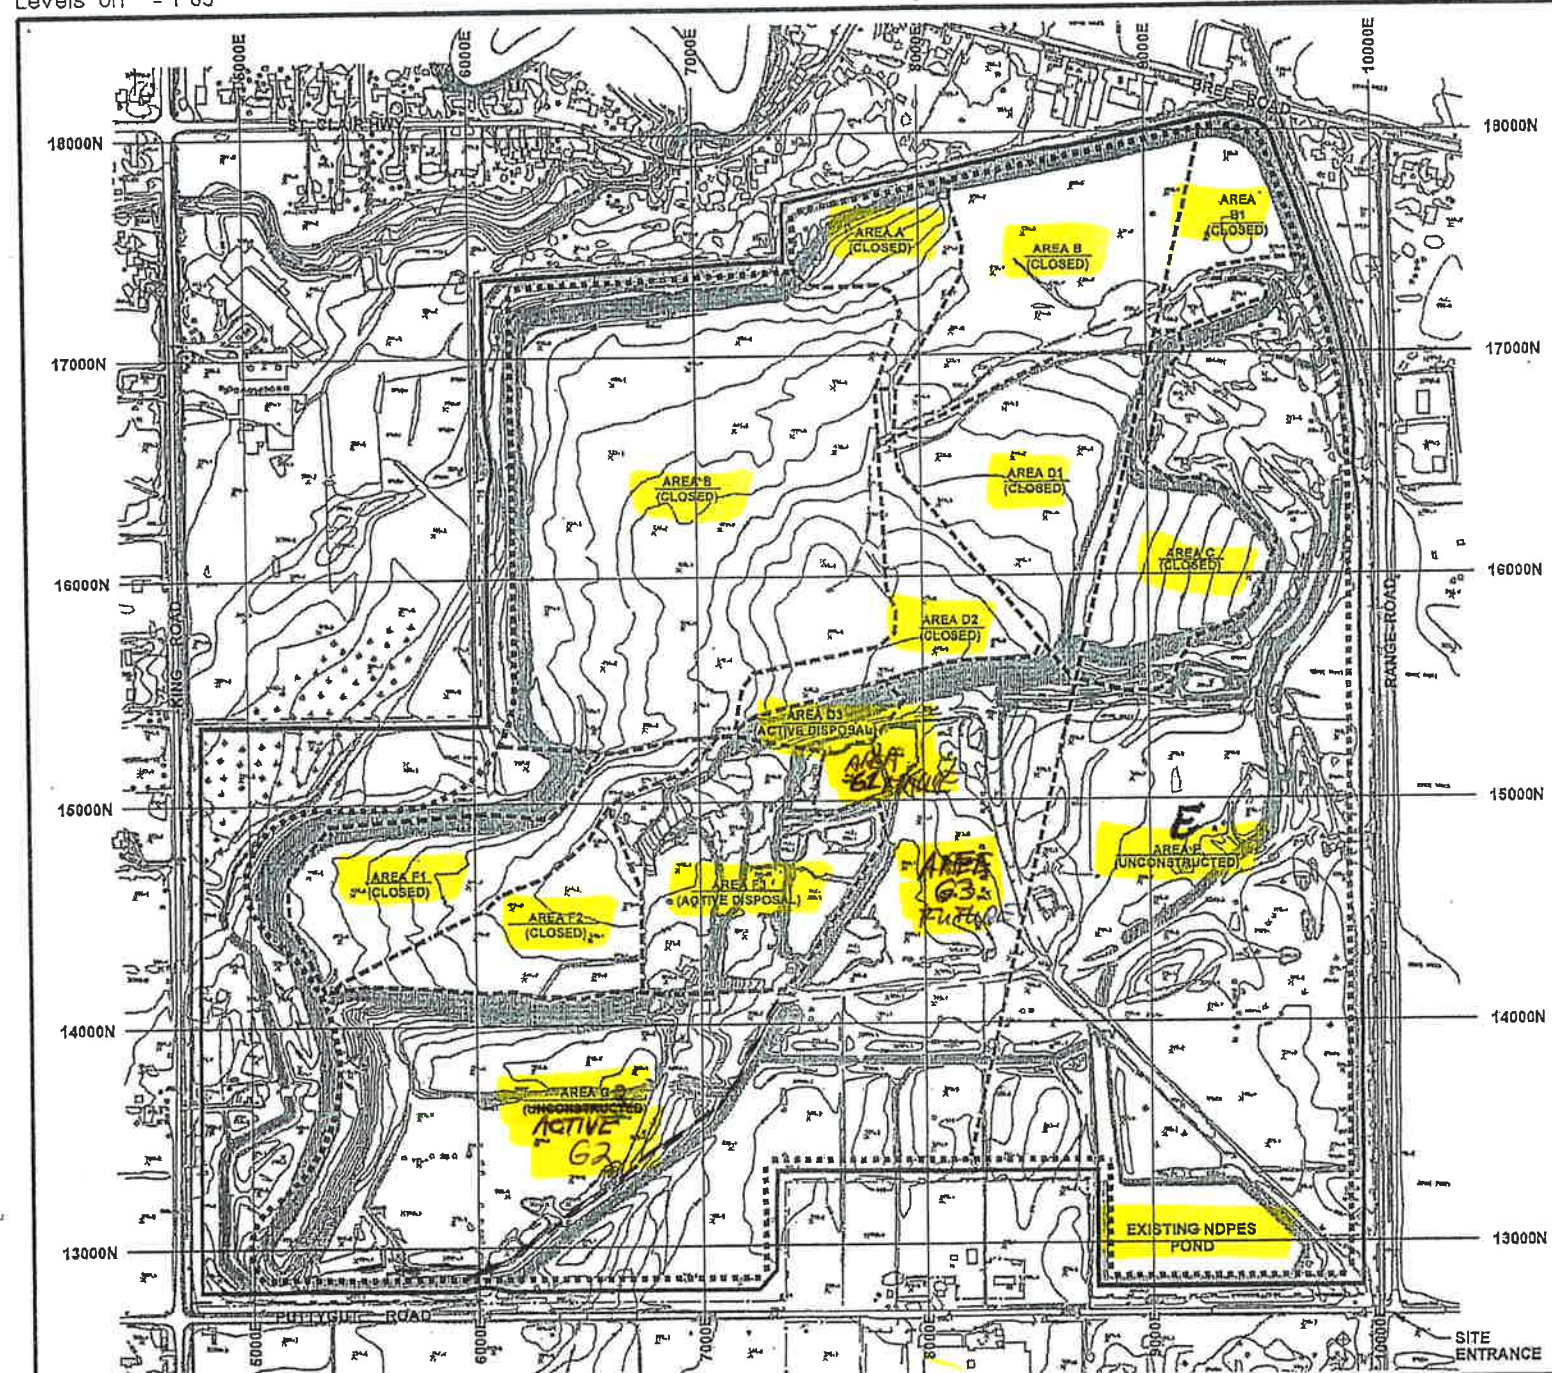
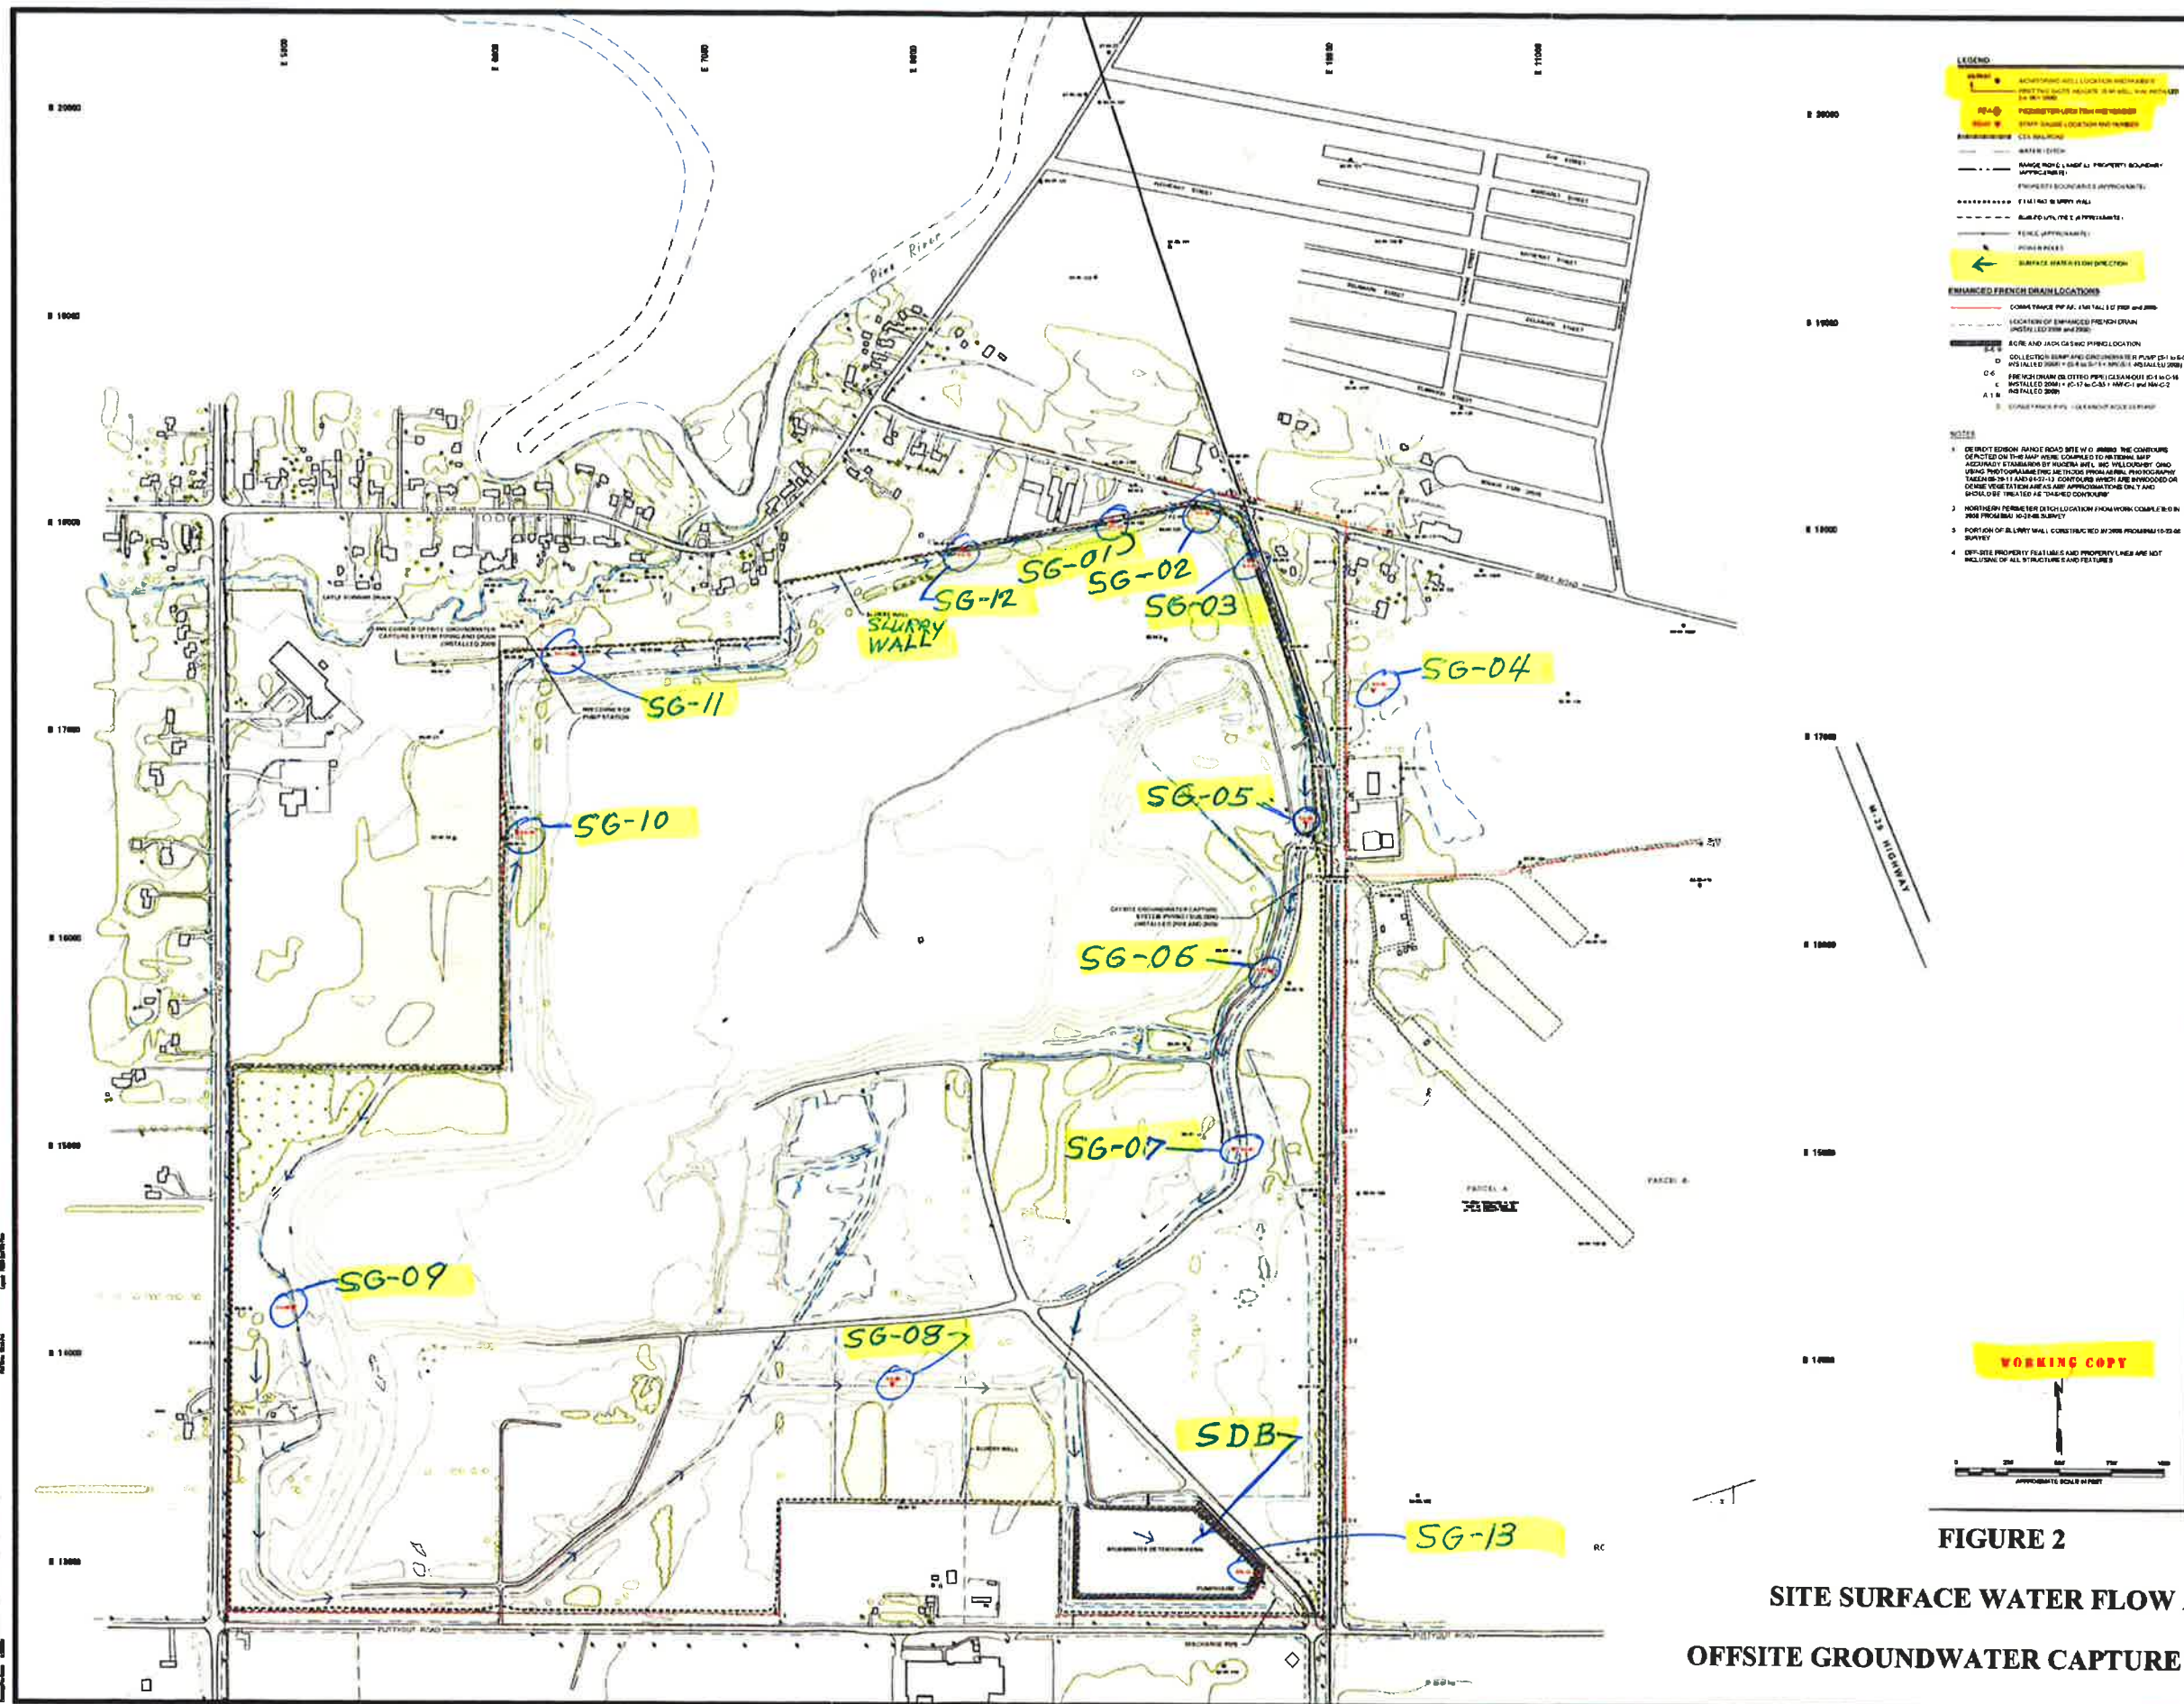
**FIGURE 1**  
**LANFILL WORK AREA PHASING PLAN**

minor woody vegetation present. These slopes are well vegetated and appear very stable. The closed area locations are identified on Figure 1 and listed in Table 2.

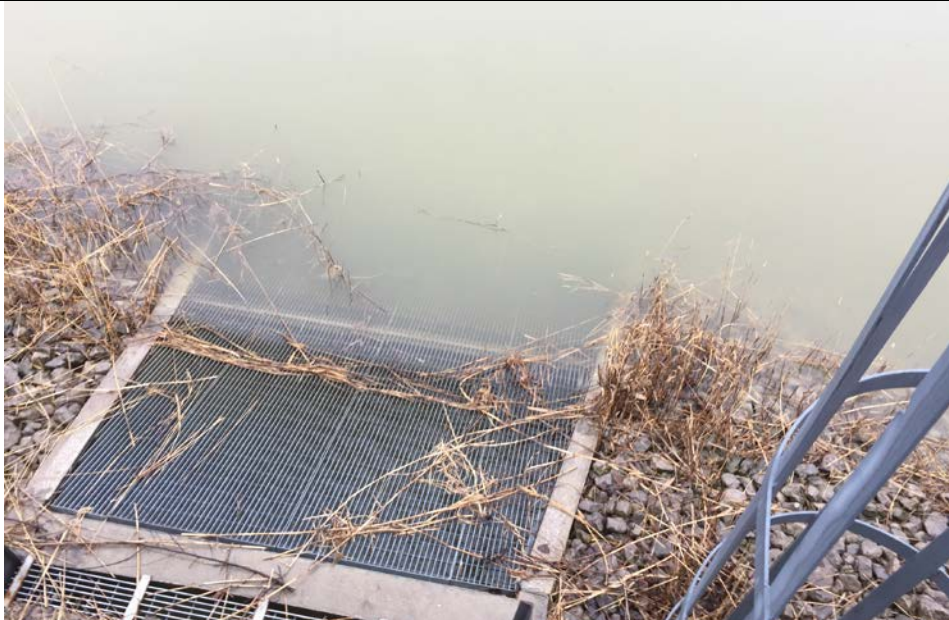
Stormwater Detention Basin: The basin and pump system appeared in good condition. Basin slopes and entrance flume also appeared in good condition with vegetation recently cut as shown in Photographs 1 and 2. Pump 1 was operating, and all pump switches were in the auto mode. The Pump control panel is shown in Photograph 4. The discharge flow meter, shown in Photograph 5, appeared to be working correctly. The basin intake screen was unblocked as shown in Photograph 3.

3. Intake Screens at SWDB. Water from Basin is Pumped Back to Power Plant Using One or More of 3 Pumps. DTE Inspects Daily and Records Pump Flow.

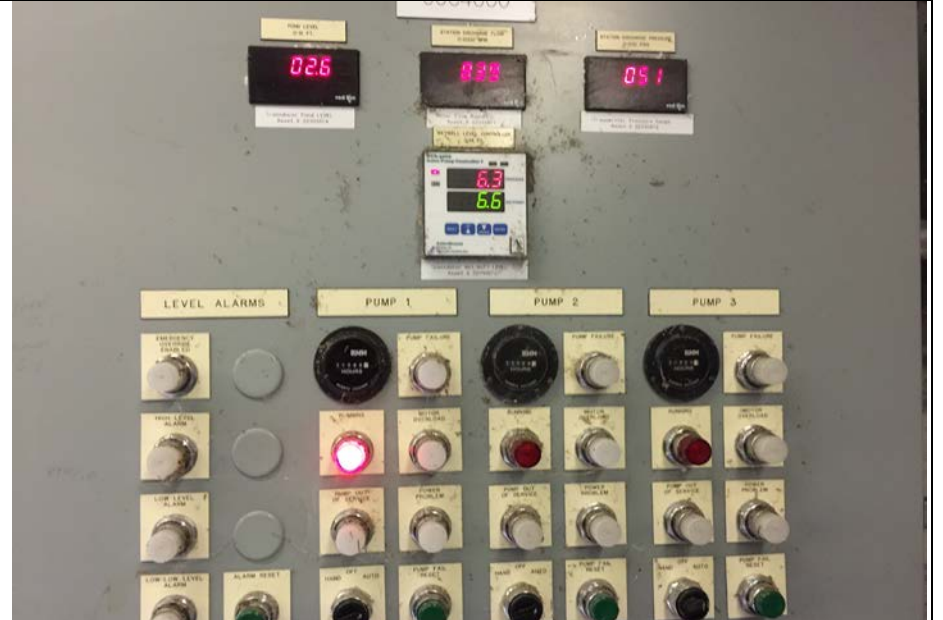
4. Pump Control Panel. Pump #1 Running. Pumps Cycle for Each Run Unless Higher Pond Level Needs More Pumps On.

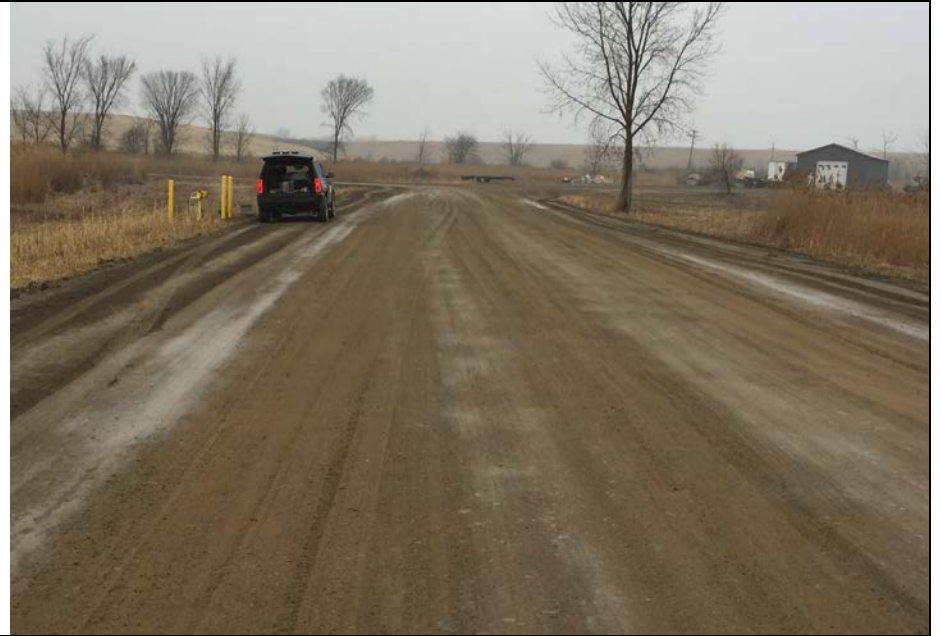
6. Views of Landfill Entrance Road and Location of 16-01. Vehicle is Consultant InProgress of Conduction Monitoring. Light Rain Falling.

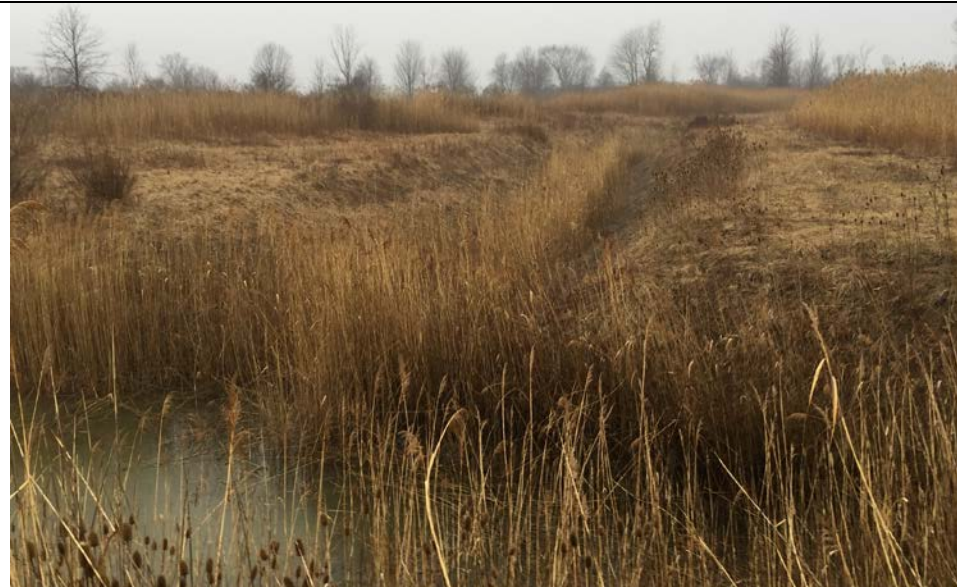
7. Looking Northeast at Drainage Ditch Draining to Canal in Photo 8. Vegetation Present, but Flow was not Blocked and Ditch Slopes Appeared Stable.

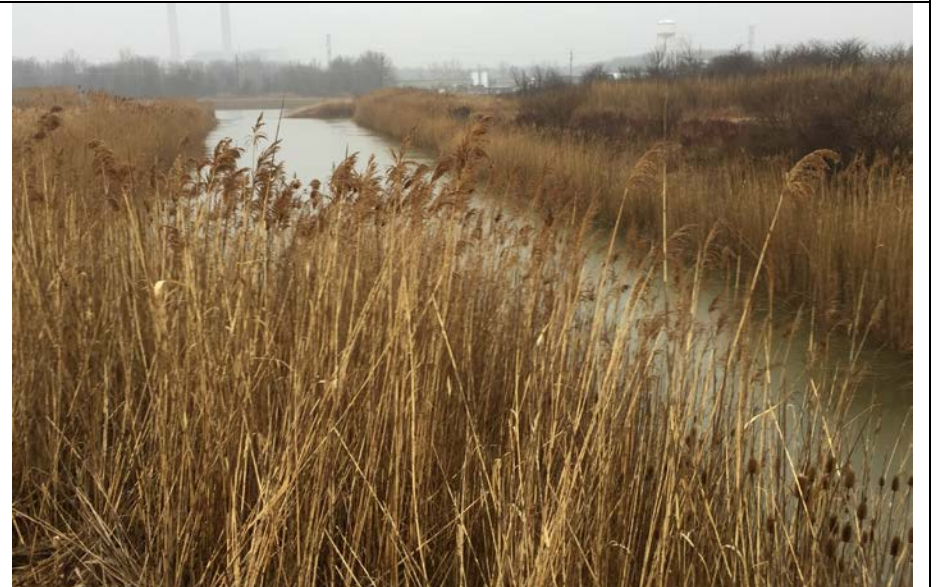
8. View of North/South Drainage Canal Leading to SWDB from Perimeter Ditch System.

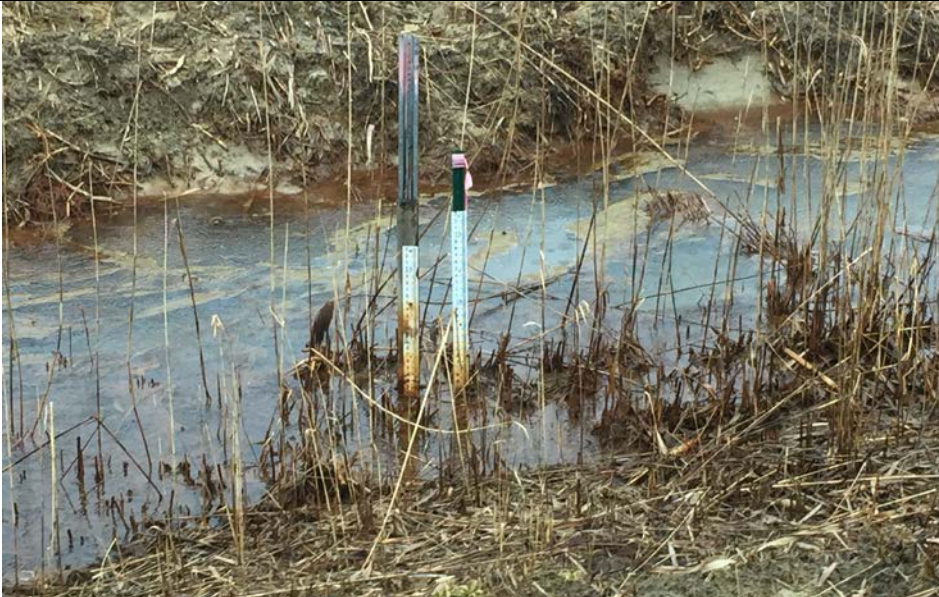
11. Looking at Perimeter Ditch Staff Gauge SG-06. No Flow Visualized.

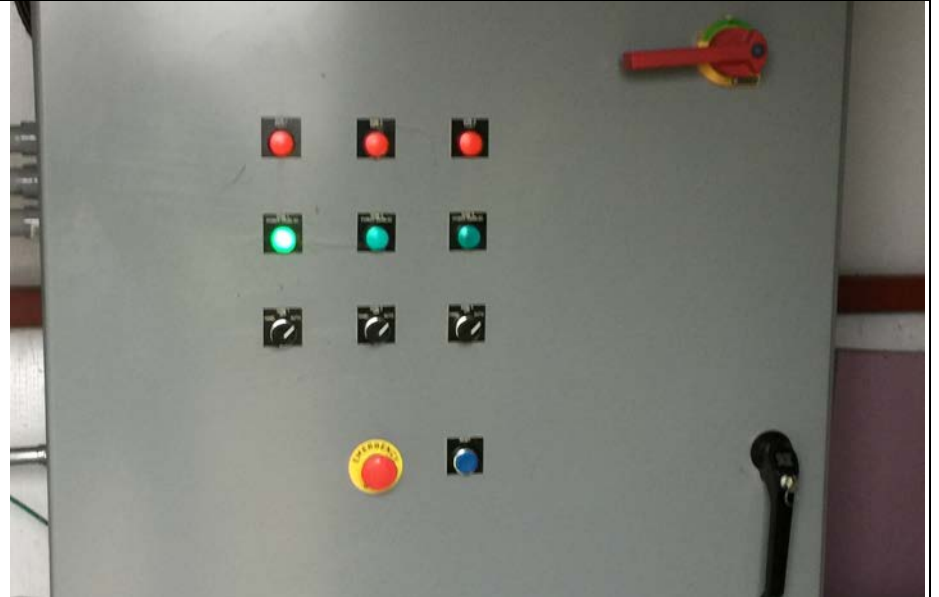
12. View of Control Panel in NE Off-Site GW Capture System Building. Zone 1 Pump Operating. All Run Switches in Auto Mode.

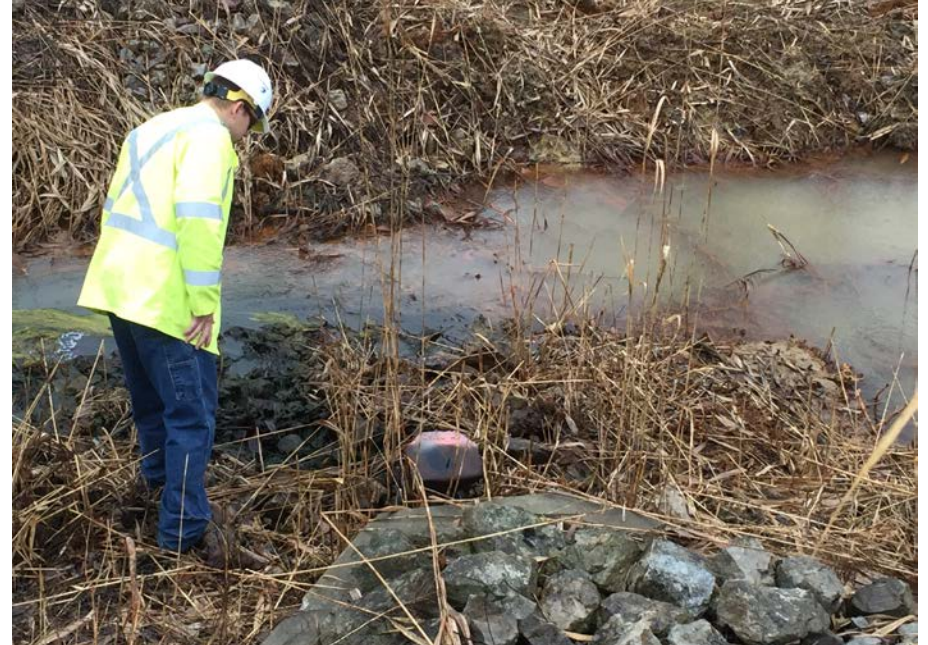
14. Looking at Trickle of Flow (09:08 AM) from Discharge from Pump in Building and Controls Shown in Photos 13 and 12, Respectively.

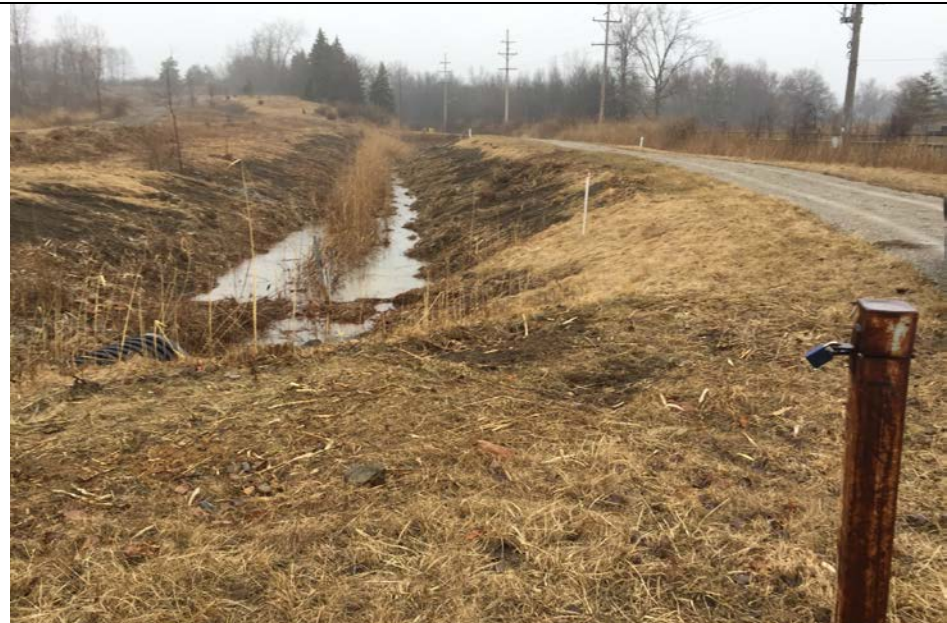
15. Perimeter Ditch Along NE Side of Landfill. Vegetation Maintenance. Piez. PZ-2 Shown. Ditch Culvert Entrance Open. No Slurry Wall Markers Present.

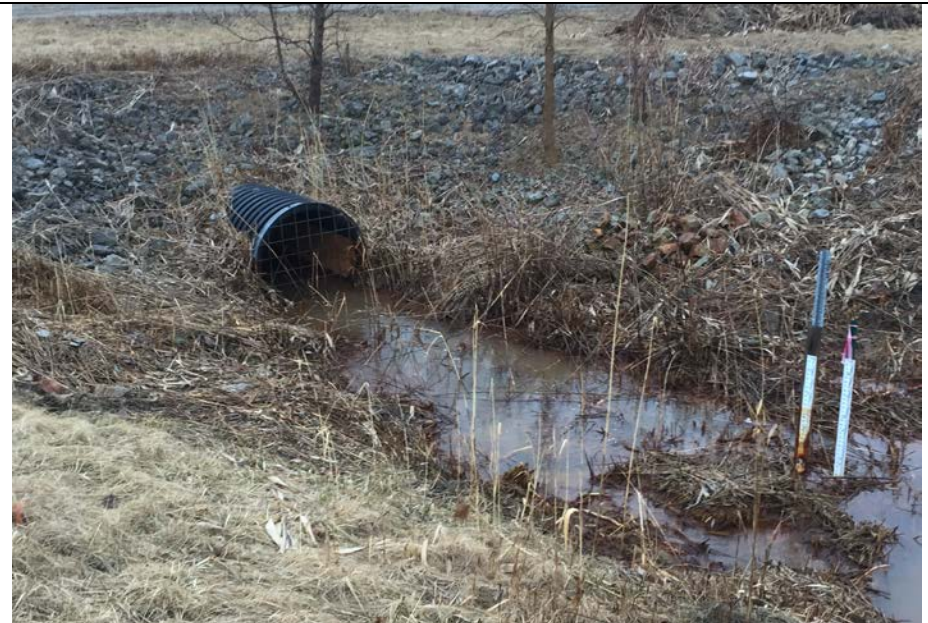
16. Closeup View of Culvert at Crossing and Staff Gauge SG-5.

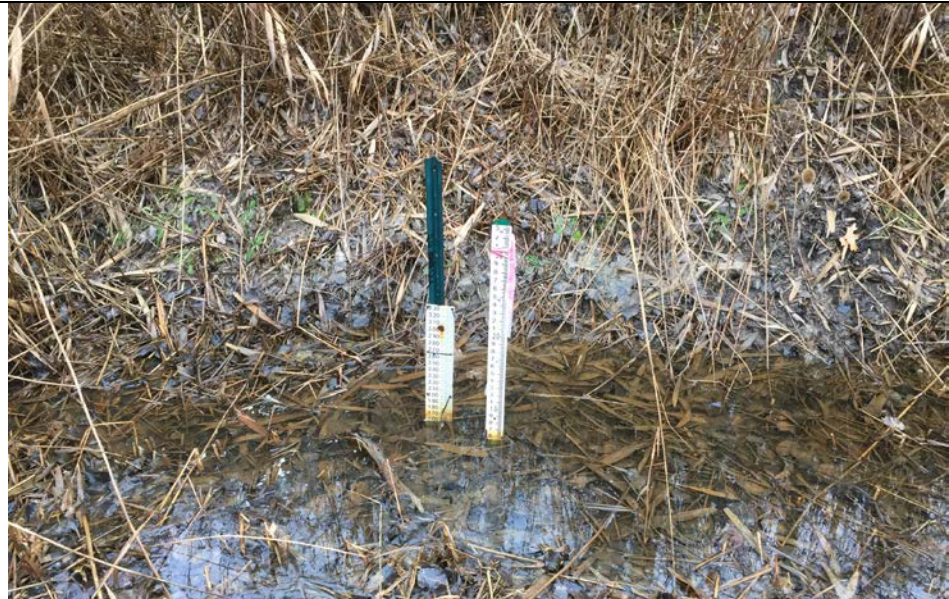
23. Looking at Perimeter Ditch and Staff Gauge SG-01. Very Little Flow, Approximately 1-2 inches/minute.

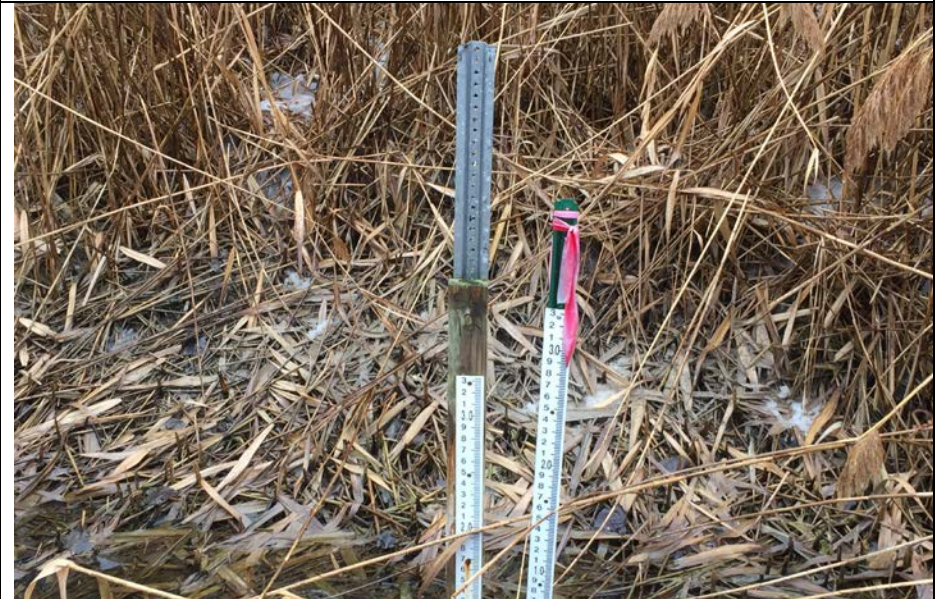
24. Close-up of Staff Gauge SG-12 and Perimeter Ditch with Heavy Vegetation. WL at Bottom of Photo. No Visible Flow.

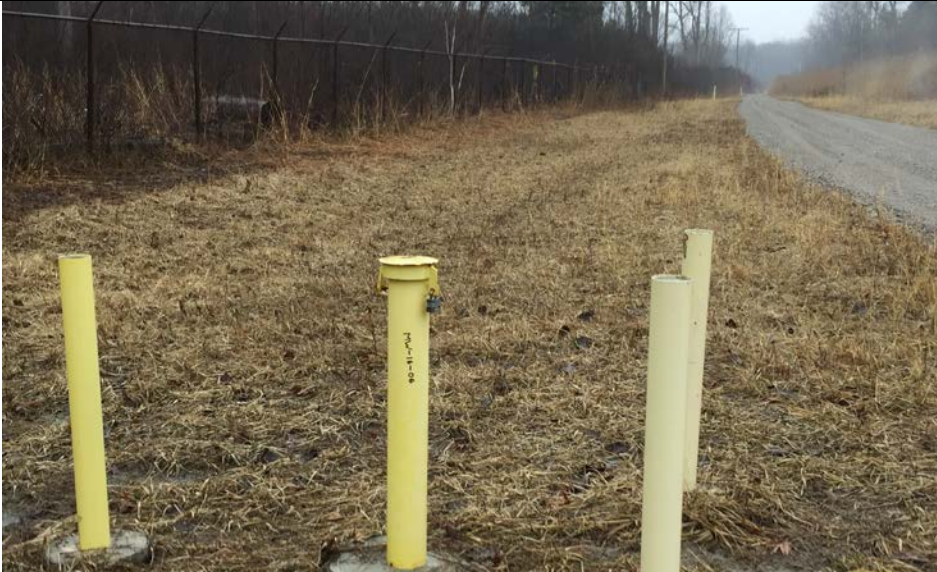
27. View of Monitoring Well MW 16-06 and Perimeter Road.

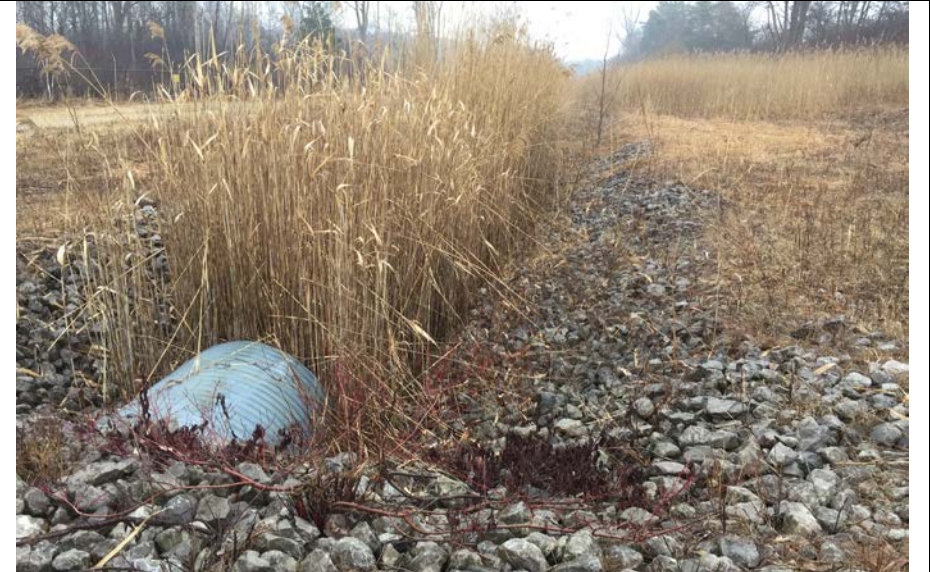
28. View of Culvert and Perimeter Ditch with Heavy Bottom Ditch Vegetation.

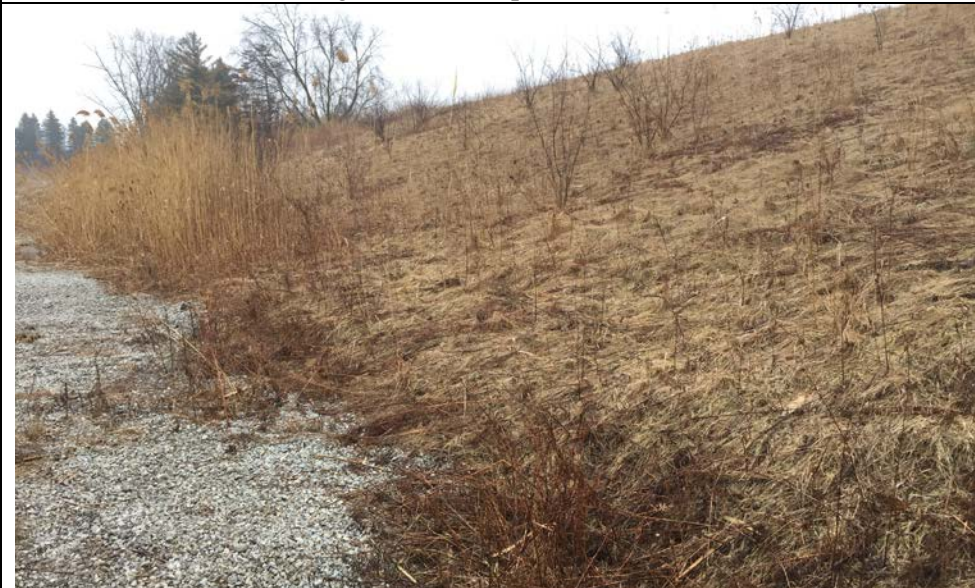
31. View of East Side Slope where Little to None Woody Tree Growth Present. Slope Uniform and Appearing Very Stable.

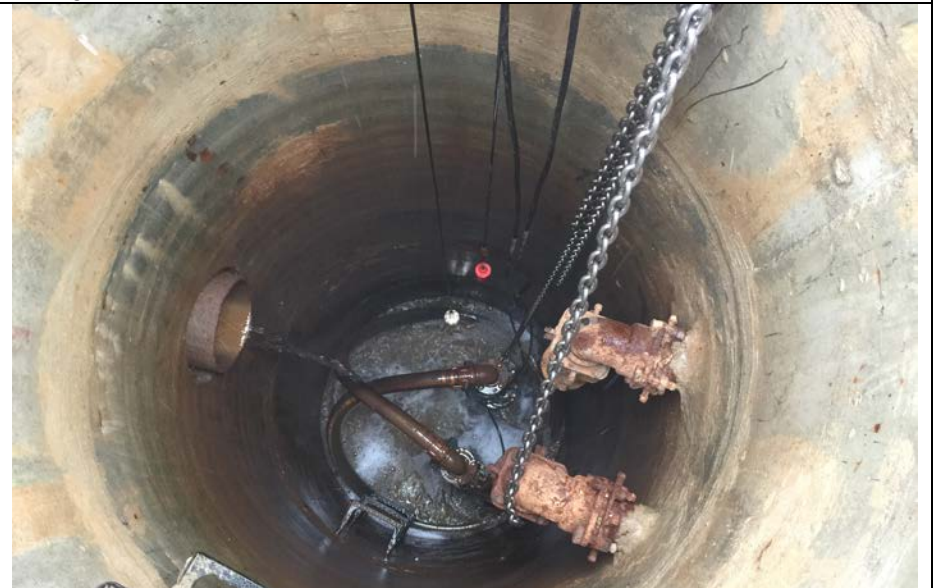
32. View of Sump, Pump Piping and Flow Pipe Entering Sump from Collection Ditch Shown in Photo 35.

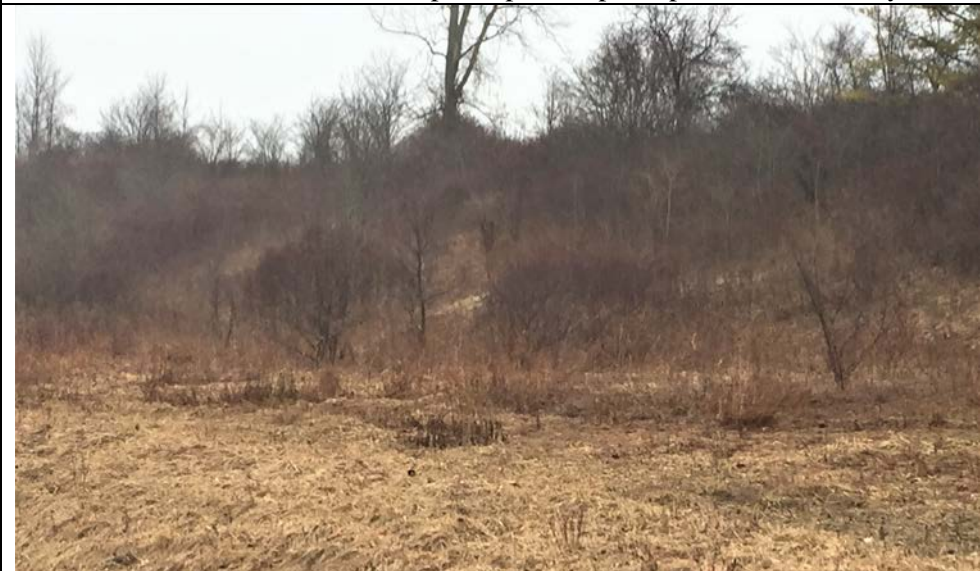
43. Heavy Brush and Tree Vegetation Along and Outside of Slope of Closed Landfill Area B, NW Side.

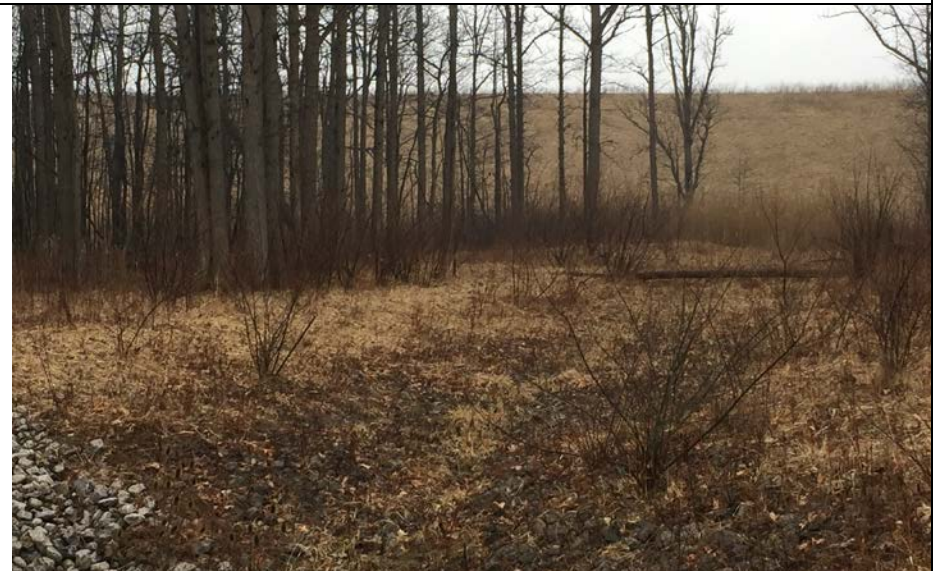
44. Vegetated Landfill Slope West Side of Area B. Lateral Ditch Draining Downstream Area. No Visible Slope Stability Problems.

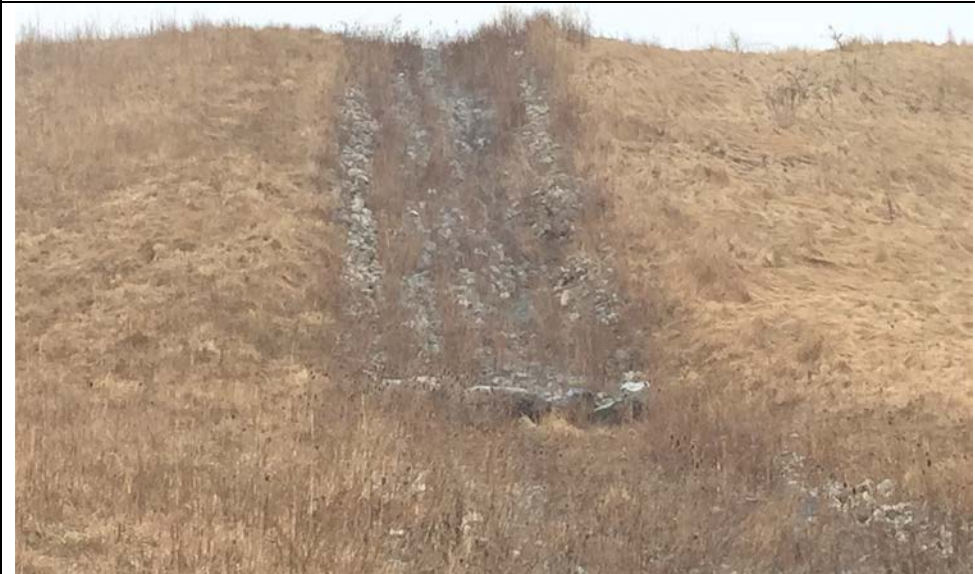
47. Major Riprapped Downchute Near West Corners of Closed Landfill Areas F1 and F2. Close Inspection Indicated Chute Stable & No Change Since 2015.

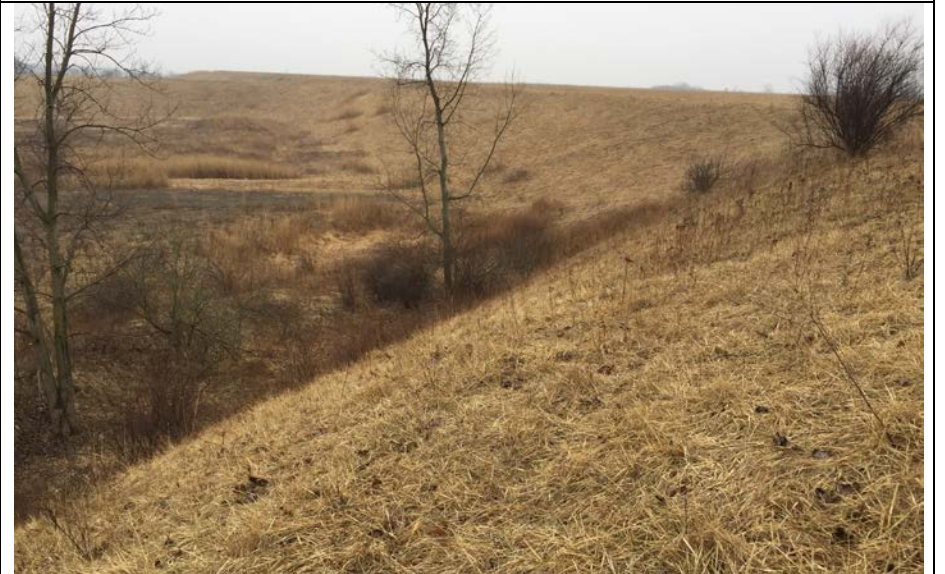
48. View of West Side Landfill Slopes of Closed Areas. Slopes Well Vegetated and Free of Any Significant Woody Vegetation.

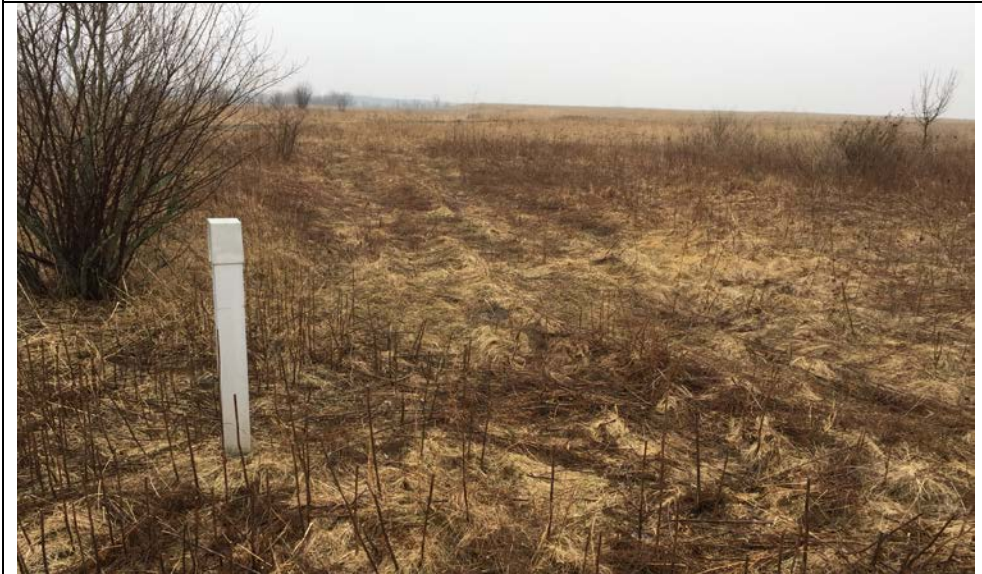
51. Fill Surface East of Closed Area D1 Near Piezometer 96-W-14.

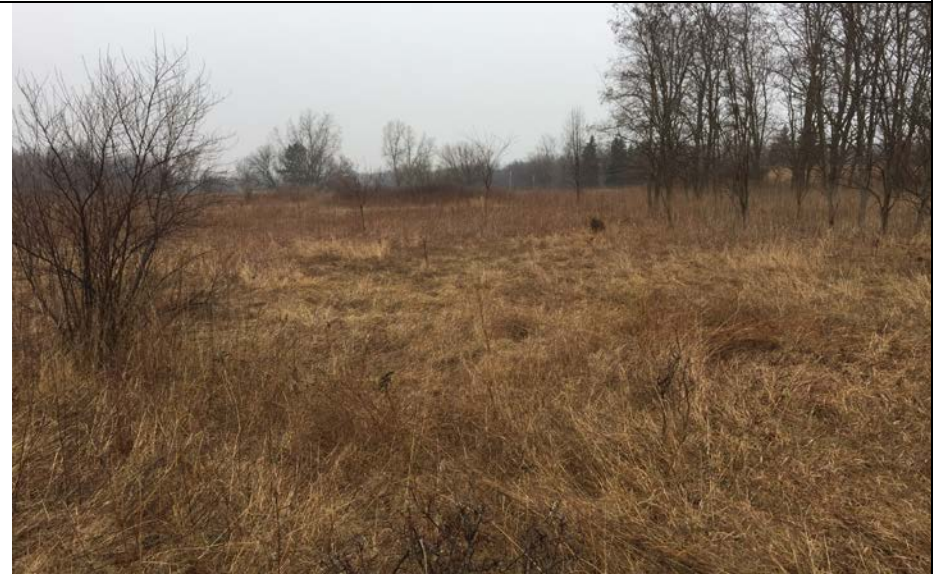
52. Looking North from Outside of Waste Area Toward Closed Area B1. Nearest Trees and Brush are Outside of Closed Area.

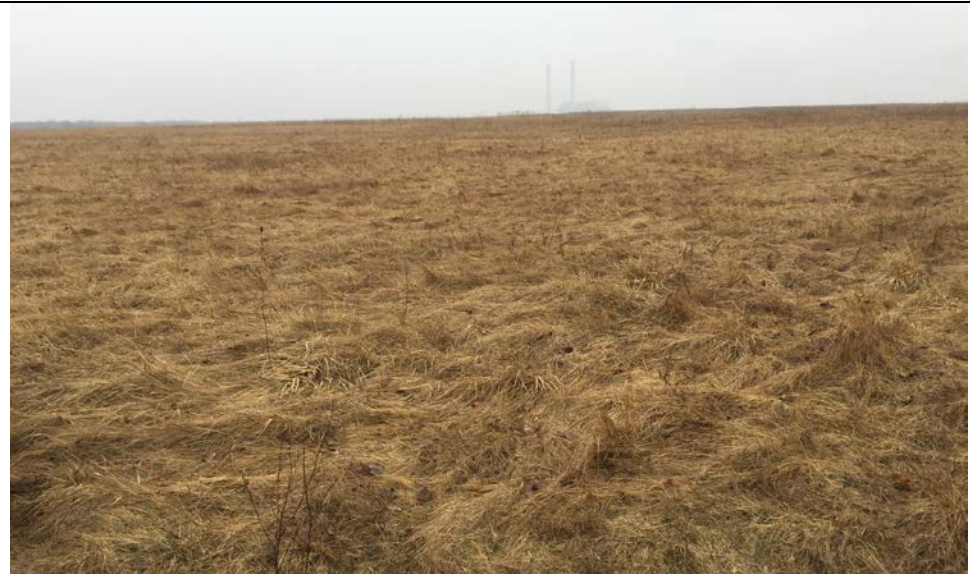
55. Typical View of Top of Landfill Surface Areas at the Northern Half of Landfill. Areas Erosion Free and Generally Free of Nuisance Vegetation

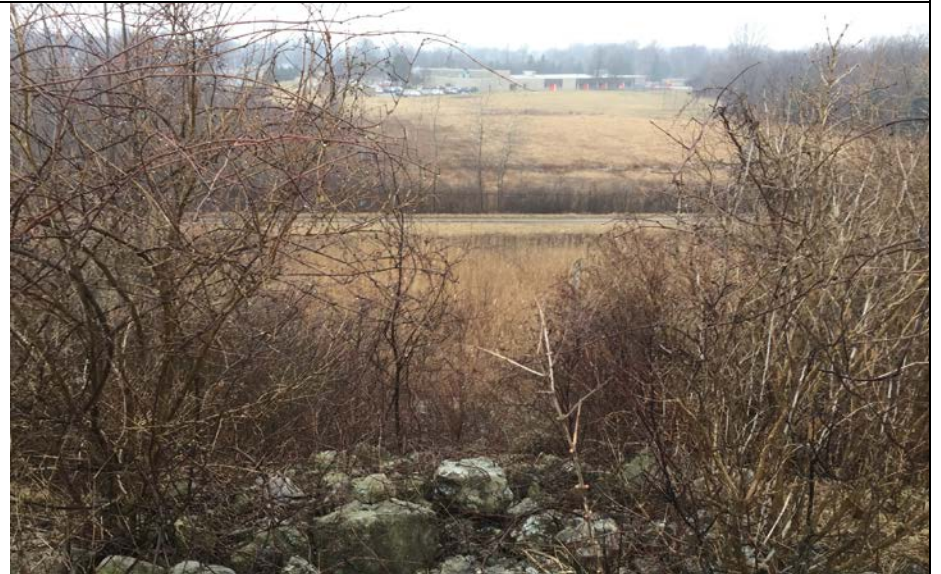
56. Looking Downslope at Downchute of North Slope of Closed Area B.

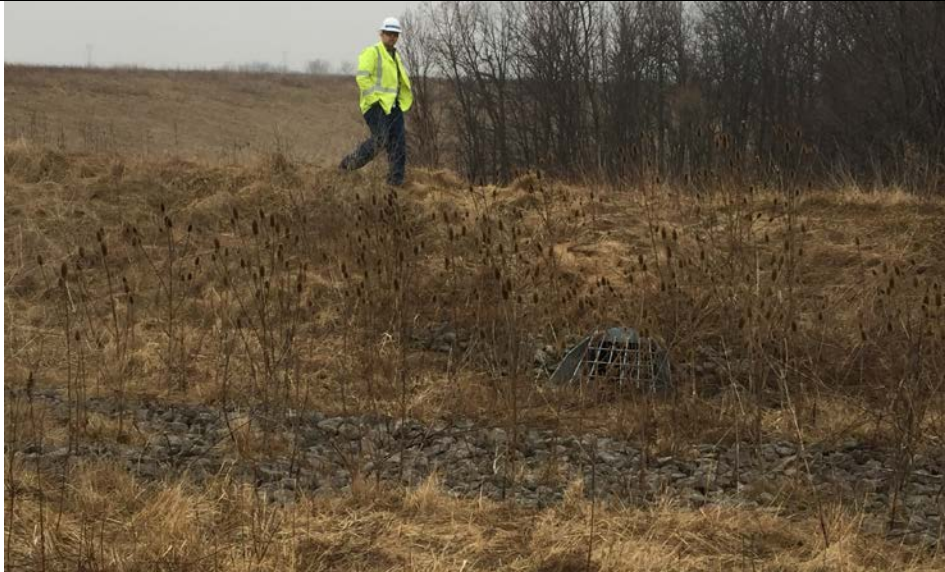
59. Landfill Surface Collection Swale Draining into Downchute Pipe. Pipe Grate Open. Bottom Slope Discharge Area of Pipe Inspected by DTE.

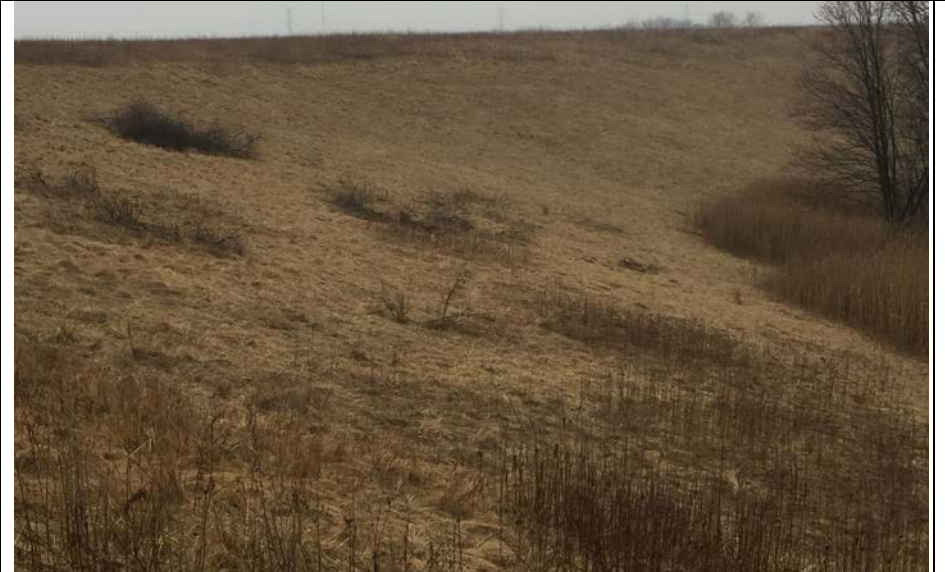
60. Looking South at Corner of West Landfill Slope Near Intersection of Closed Areas B and F1. Slope Appeared Stable and Well Vegetated.

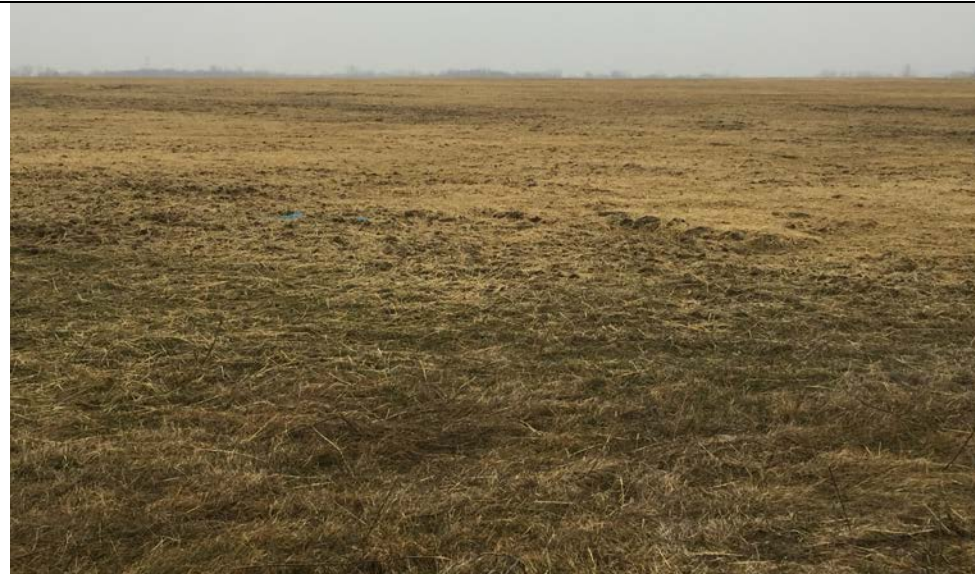
63. Another View of Seeded Final Cover of Area F3. No Visible Surface Erosion.

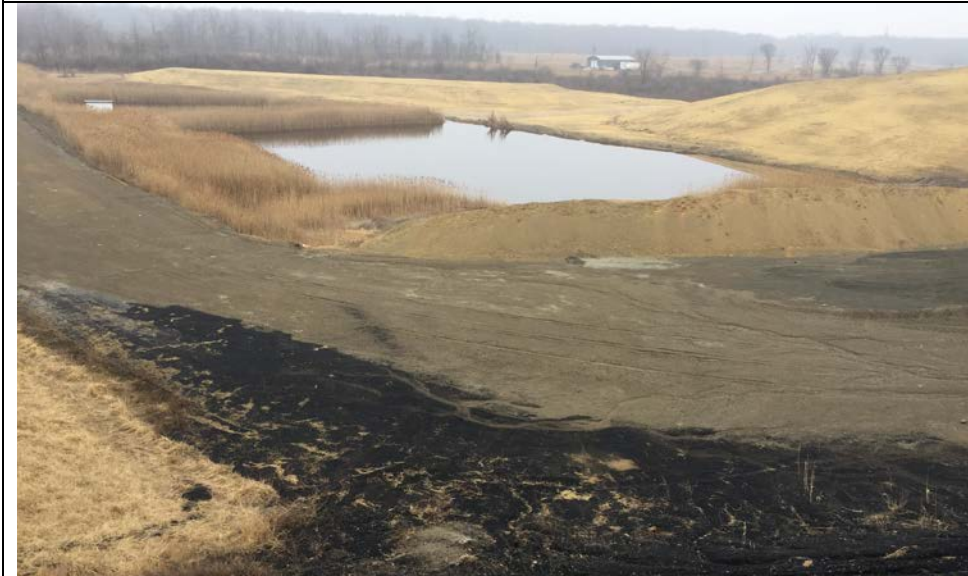
67. Looking East at Internal Stormwater Pond and Seeded Fill Stockpile (Top Left) and Area F3 Interim Seeded Slope (Top Right). No Significant Erosion Along Road.
