**2018 ANNUAL INSPECTION REPORT  
RANGE ROAD LANDFILL  
ASH DISPOSAL FACILITY**

**China Township, St. Clair County, Michigan**

January 2019

**APPENDIX B**  
**DTE Range Road Landfill Annual Inspection 29 March 2018**

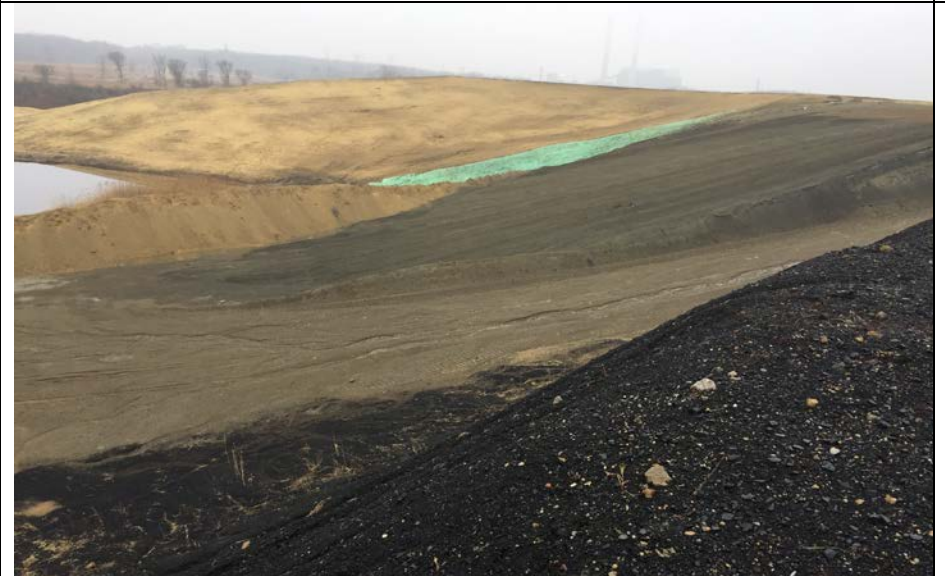
New or fresh conditioned CCR waste in Area G2 Phase I is shown in Photographs 81, 82, 110 and 111. Placement and compaction procedures of conditioned CCR waste closely follows the Ash Filling Procedures discussed in the Landfill Development Plan. CCR waste is now being placed and compacted in horizontal lifts. The temporary seeded slope along the east side of Area F3, reported by DTE as constructed in horizontal layers, appeared stable, and where currently seeded appeared well protected until vegetation grows. The slope is shown in Photographs 67, 68 and 77.

68. Internal Haul Road and Area F3 Interim Seeded Slope. Photo Right Side Match to Photo 67. Some Erosion Gully into Pond in Center of Photo 67.

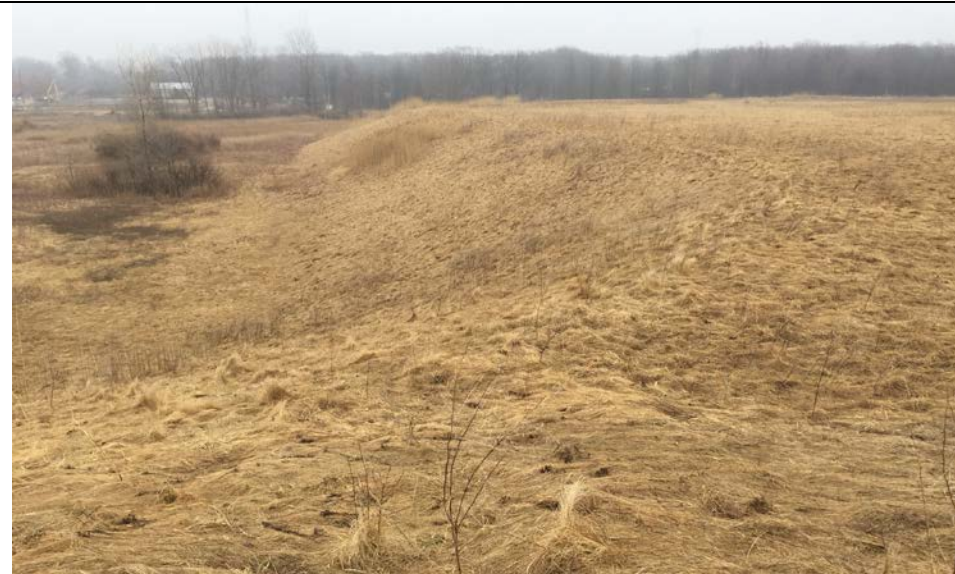
71. Looking South at Slope and Surface of Closed Area C. Slope and Surface Well Vegetated.

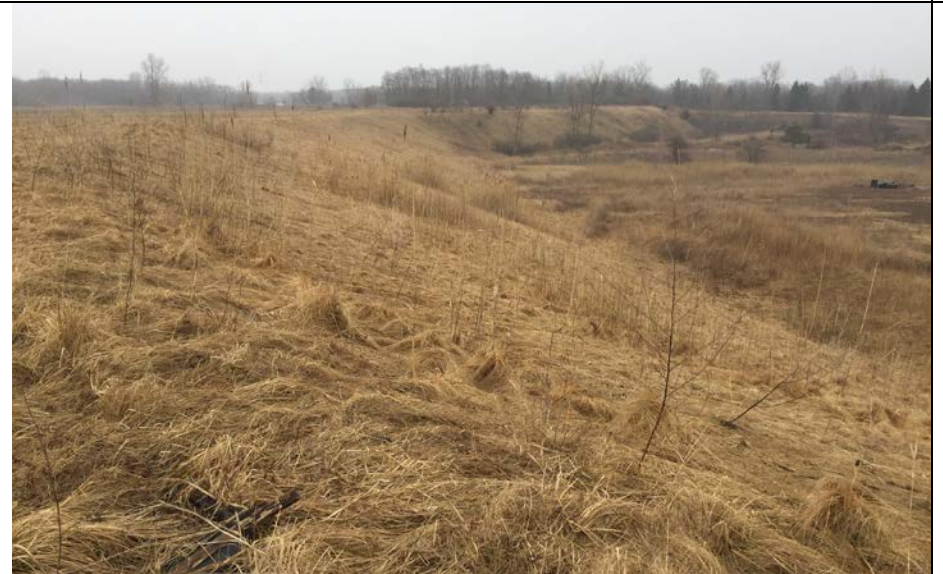
72. Looking North at Slope of NE Side of Closed Area D1 and Far South End Slope of Area B1. Slopes Well Vegetated with Some B1 Woody Vegetation.

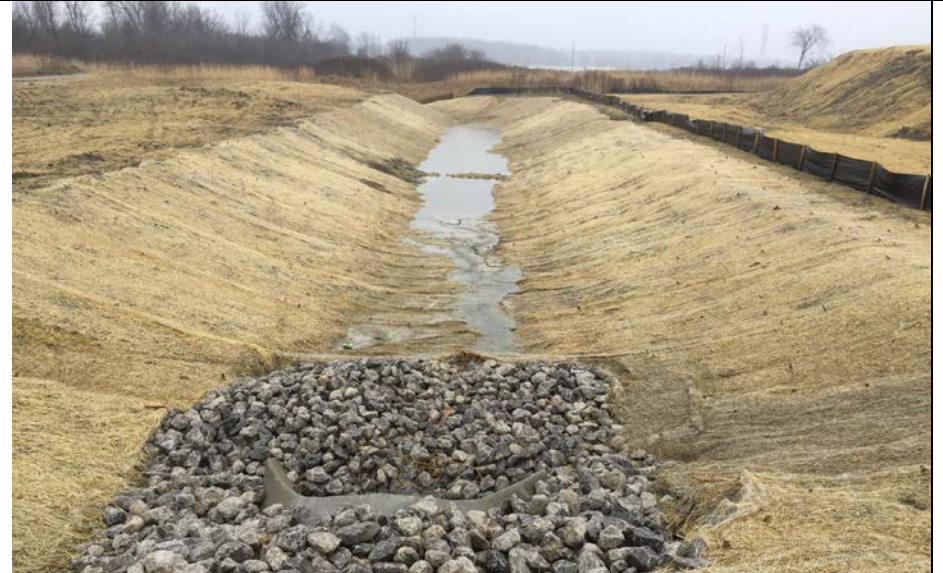
76. New Internal Drainage Ditch, Culvert and Riprap Check Dam Draining Flow from Internal Ponds. Ditch Connects with Landfill Perimeter Ditch.

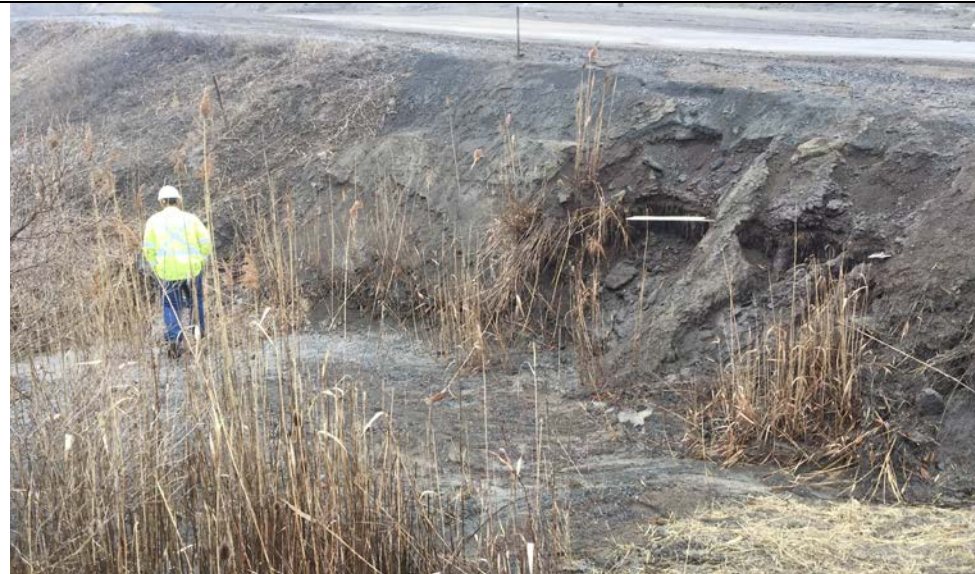
79. Discharge Location of Old Culvert Beneath Haul Road. Some Previous Road Slope Erosion.

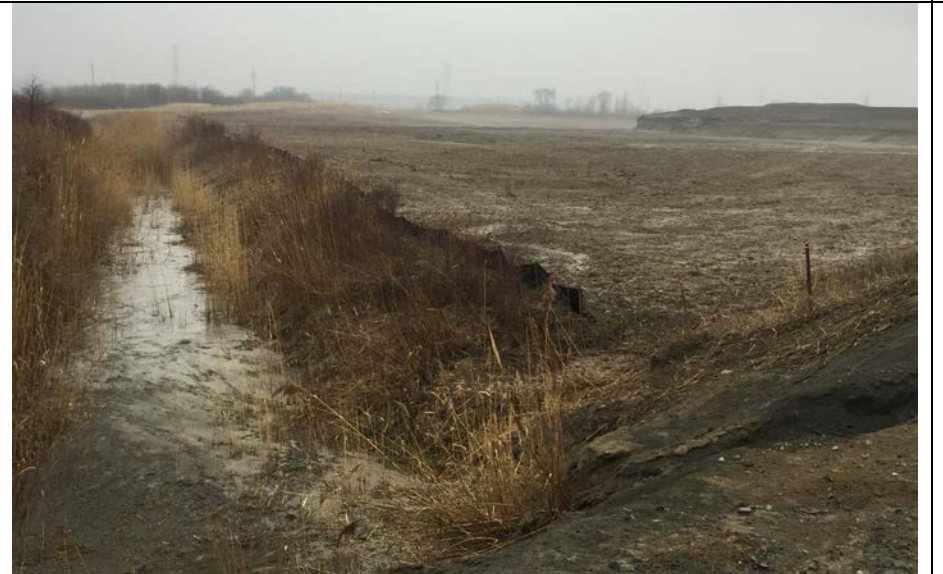
80. Old Drainage Ditch Transferring Discharge from Old Culvert.

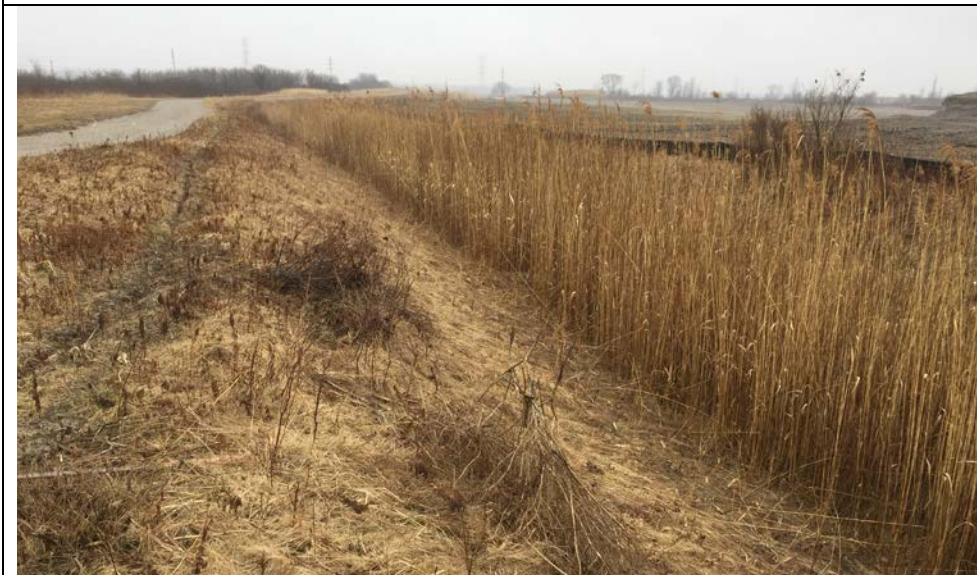
83. Landfill Perimeter Drainage Ditch at South End of Landfill. New Road Along Side of Ditch. Vegetation Cut Along Road Side. Silt Fence is Perimeter Marker of Future Area G.

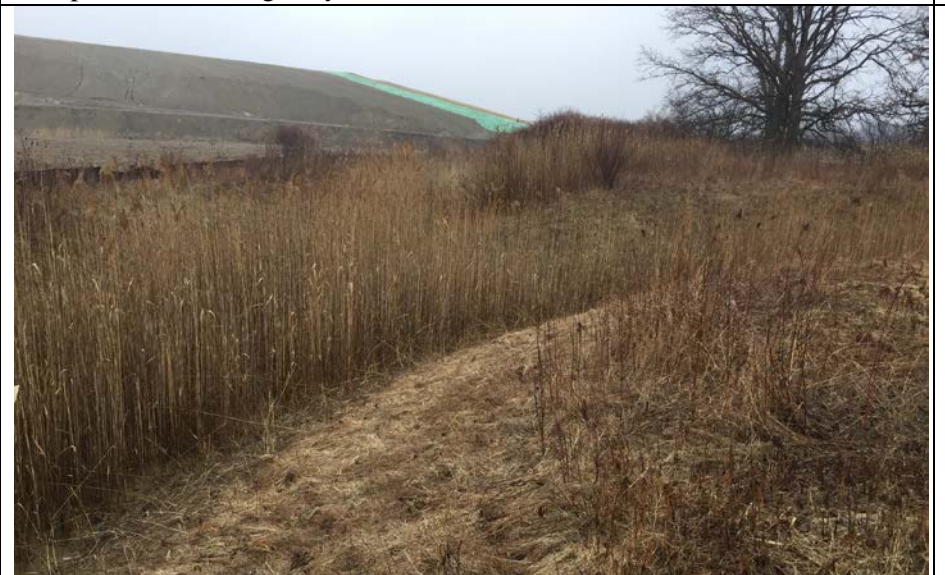
84. Looking Northeast at Ditch Shown in Photo 83.

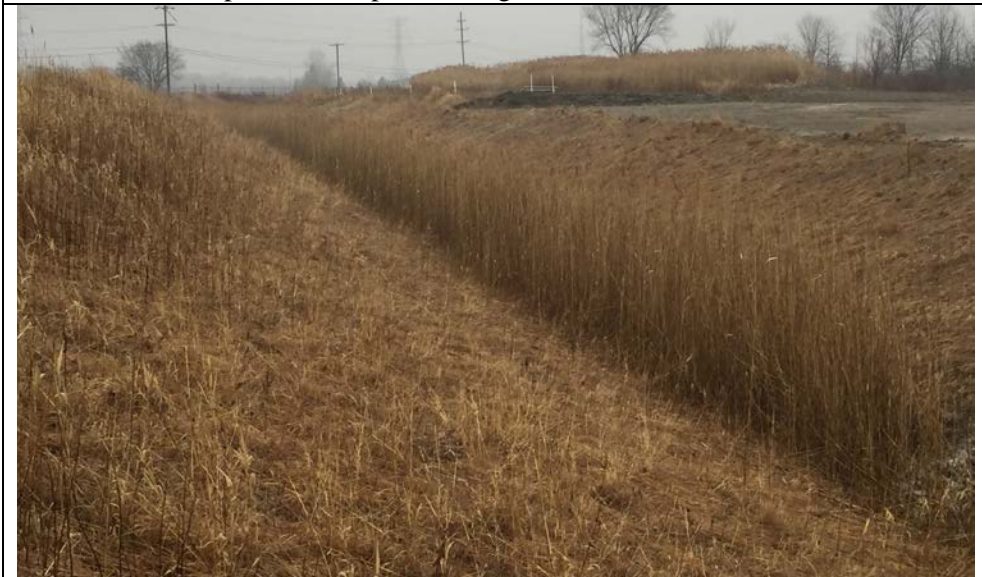
87. Looking Southwest at Perimeter Ditch at West Side of Area G2. Ditch Slopes Appeared Stable and Well Vegetated. Slope Vegetation Cut Late 2017 or Early 2018.

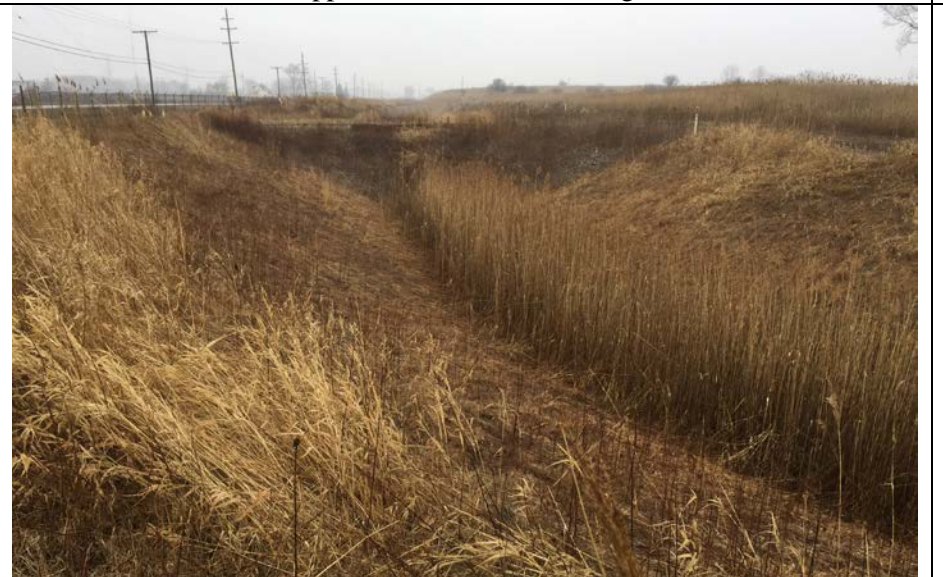
88. Looking West at Perimeter Ditch. Slope Vegetation Has been Cut and Slopes Appear Stable and Well Vegetated. Site Road Crosses Ditch at Top.

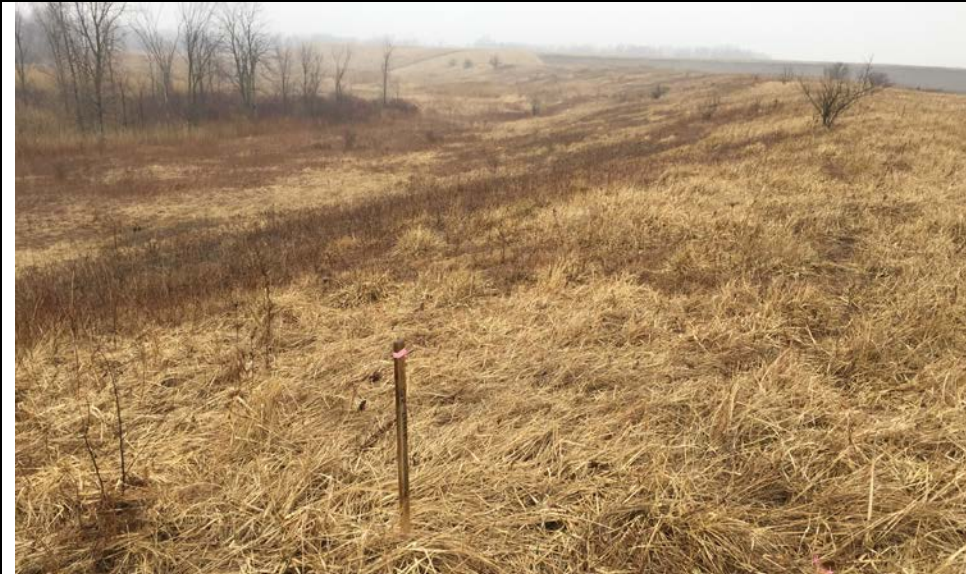
91. Stake Located on SW Corner End of Unconstructed Portions of Area G2. Slope Woody Vegetation Planned to be Removed when Future Construction Started.

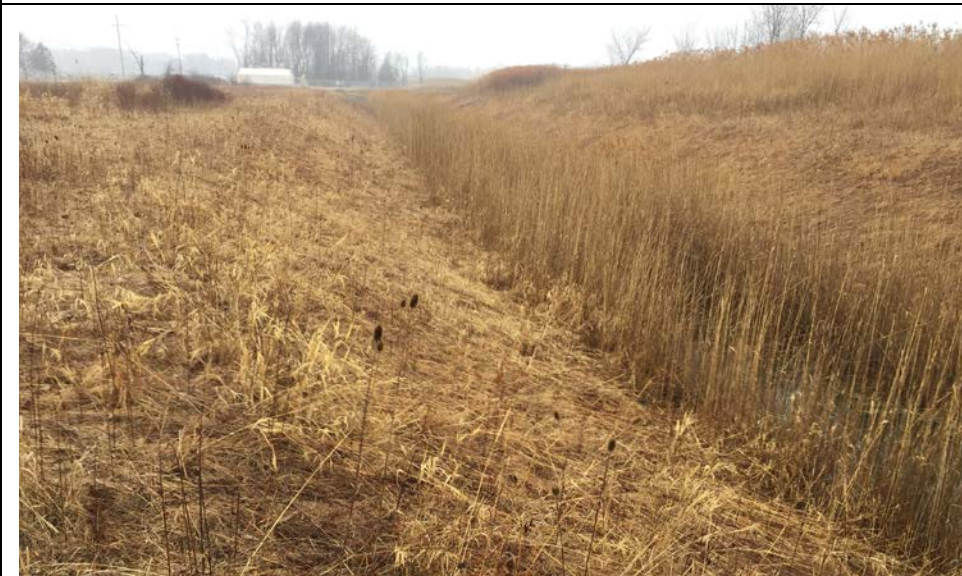
95. Looking North Along Portion of Perimeter Ditch Parallel to King Road and Reconstructed in 2010. Couple of Slope Erosion Gullies at Far End Photographed.

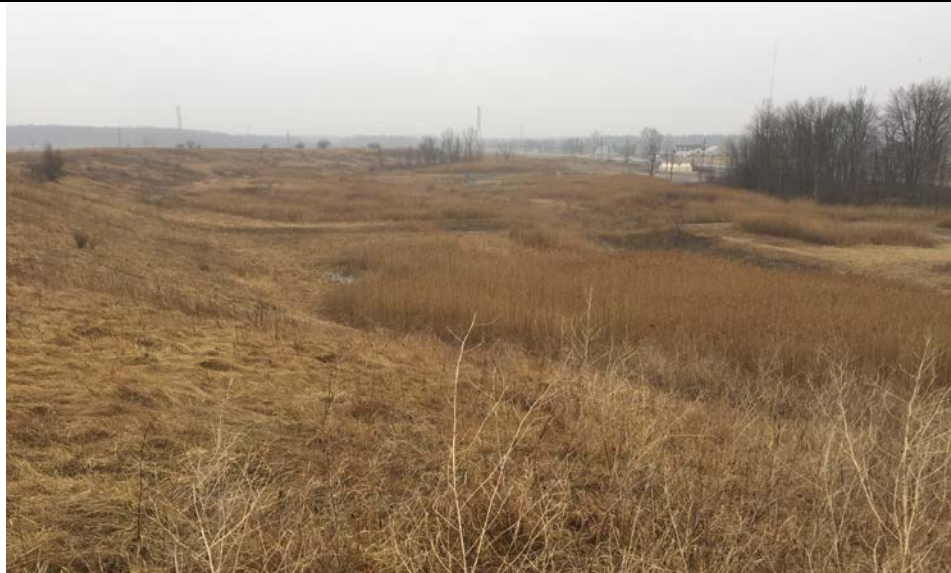
107. Looking South at West Area Outside of Landfill Storage. Landfill Lateral Drains into Perimeter Ditch Right Side of Photo. Occasional Tree Along G2 Slope to be Removed.

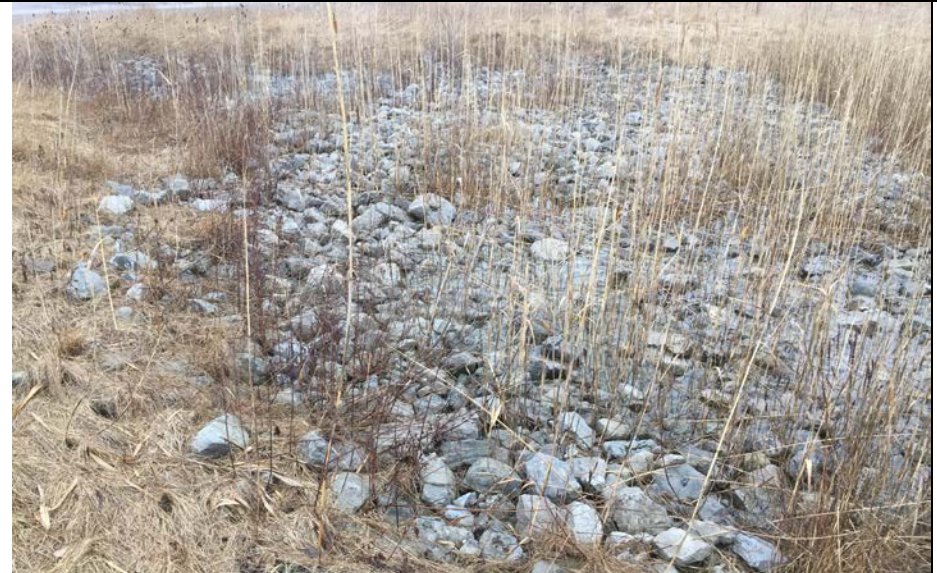
108. View of Riprapped Filled Swale at Top of Closed Area F2 as the Swale Approaches the Downchute Shown in Photo 110. Water in Middle.

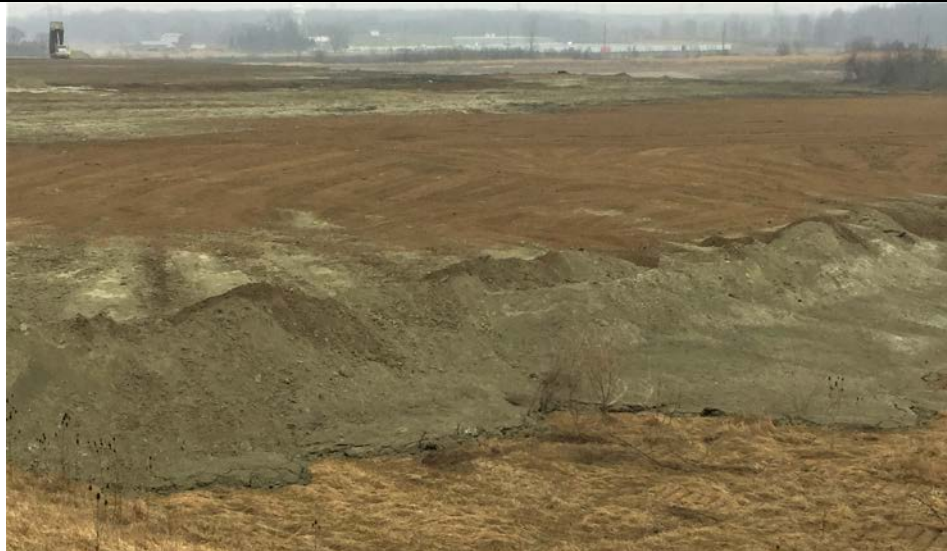
111. Waste Unloading InProgress. Piles Placed at Western Edge of Active G2 Phase 1 Area. Removal of Surface Vegetation at Western Edge Appears Not Required.
