**DTE Electric Company**  
One Energy Plaza  
Detroit, Michigan 48226

# **2019 ANNUAL INSPECTION REPORT SIBLEY QUARRY LANDFILL**

**Trenton, Michigan**

**Geosyntec**

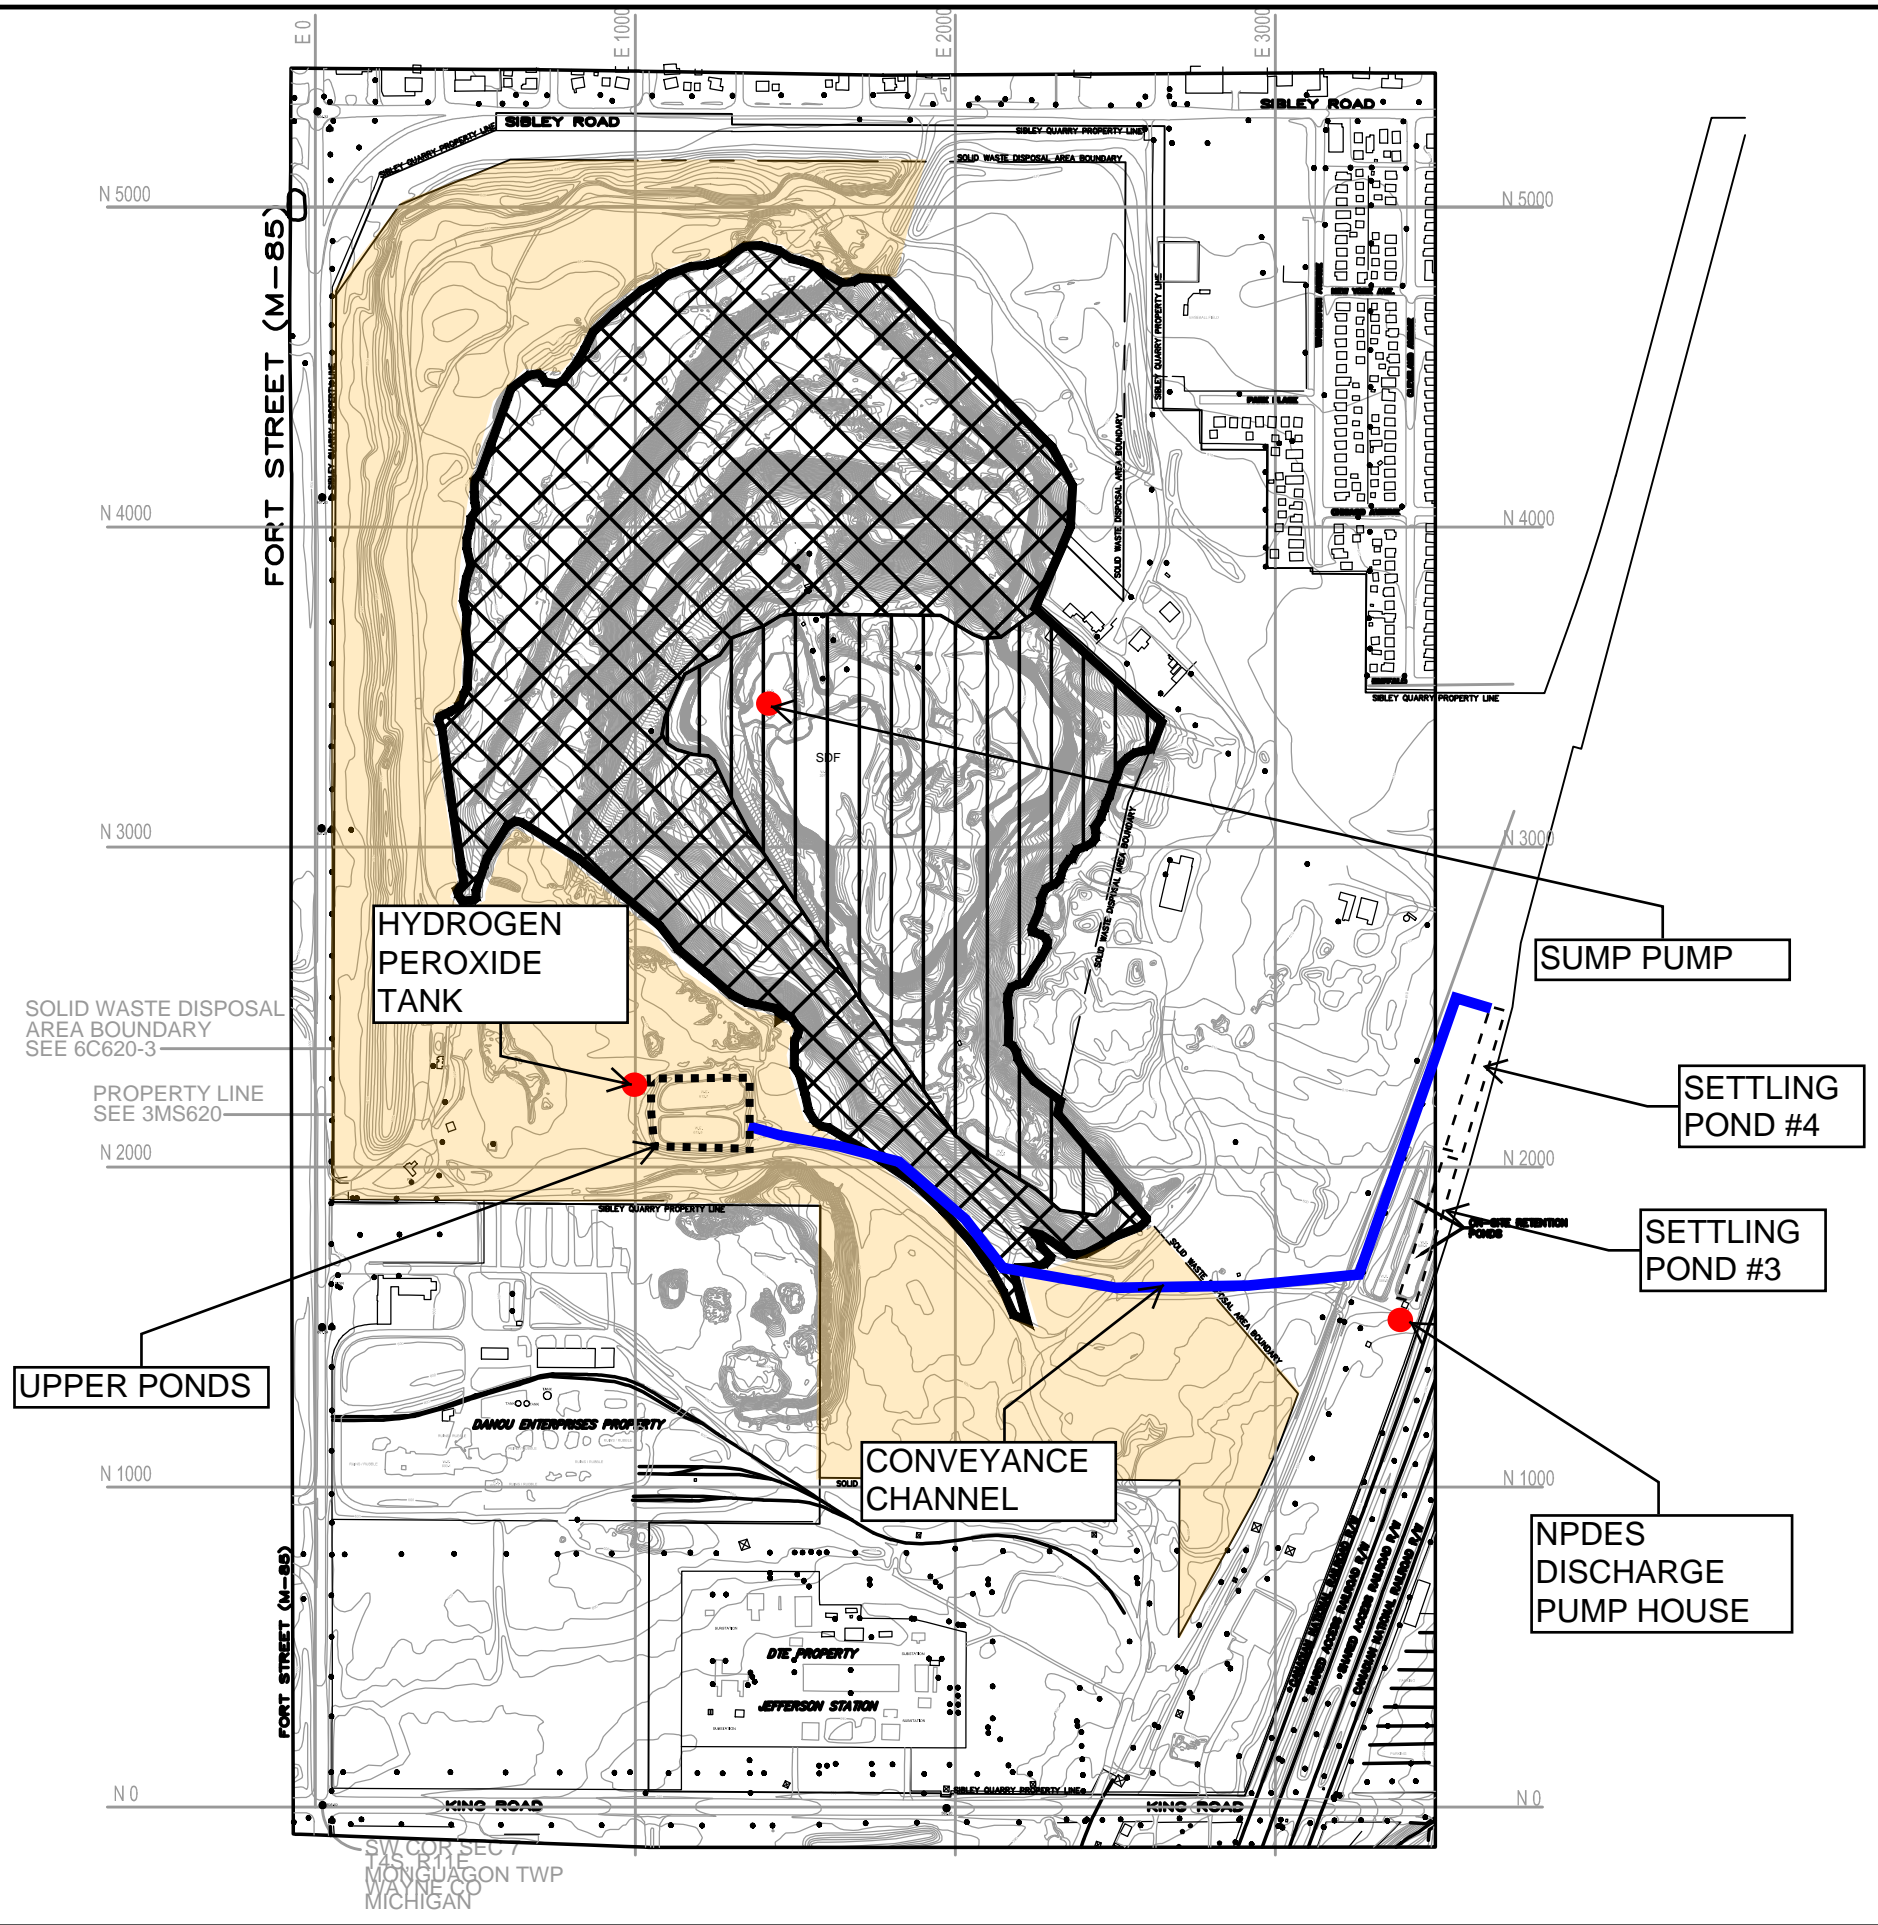
Figure 1 Approximate Extent of Waste at Sibley Quarry Landfill

APPROXIMATE AREA OF WASTE REQUIRING FINAL COVER (64.2 AC)
-
