**DTE Electric Company**  
One Energy Plaza  
Detroit, Michigan 48226

**2022 ANNUAL  
INSPECTION REPORT  
SIBLEY QUARRY LANDFILL**

**Trenton, Michigan**

January 2023

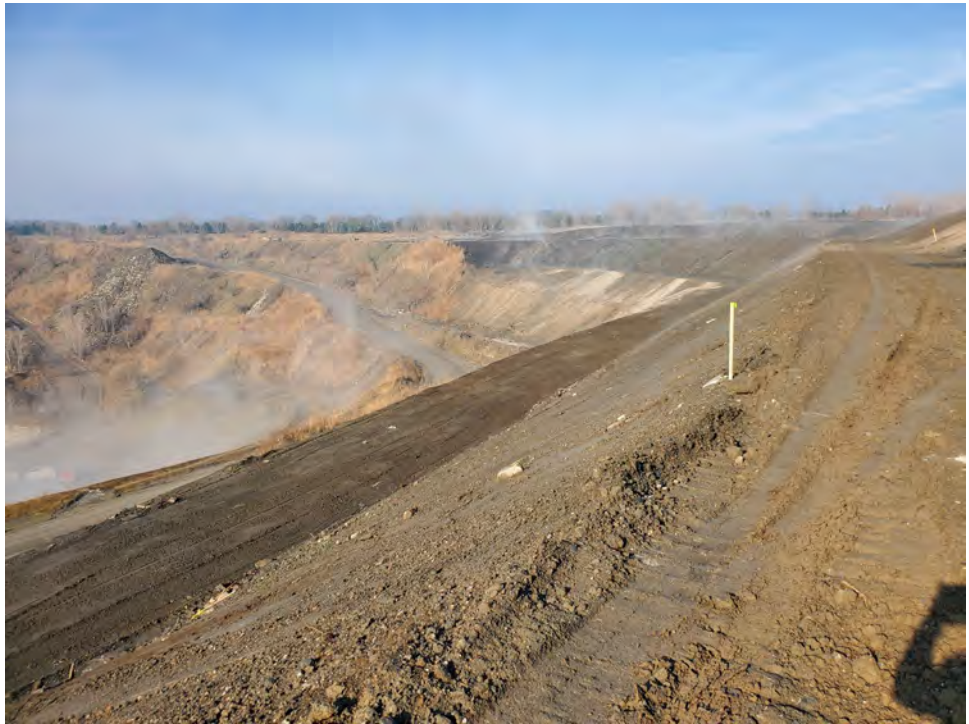
Photograph 6

Date: 4/5/2022

Comments:  
Stockpiled material from regrading of northern slopes in the top of the active filling area. (Northwest)

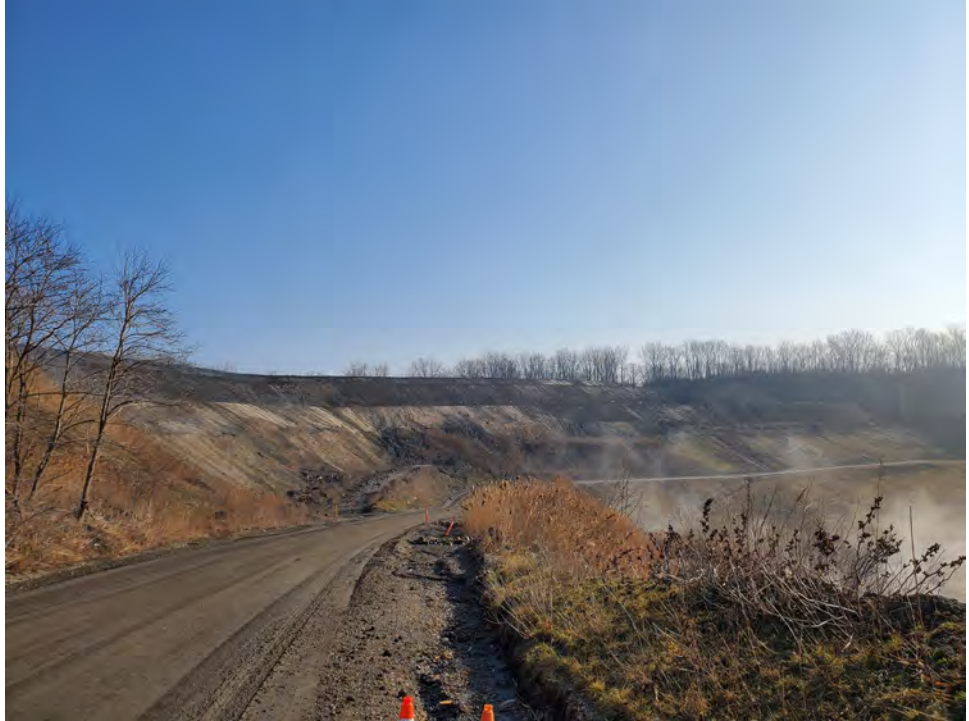
### Photograph 8

Date: 4/5/2022

Comments:  
Constructed drainage collection and filter layer at the bottom of the quarry. Bottom ash is now being placed in the bottom of the quarry. (Southeast)

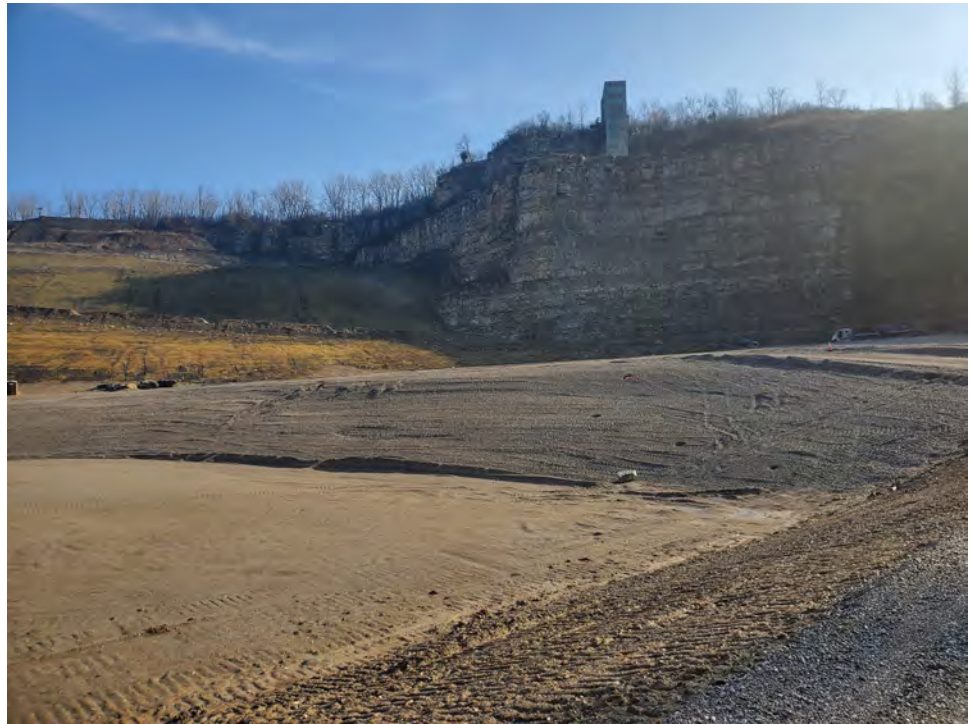
Photograph 10

Date: 4/5/2022

Comments:  
Constructed drainage  
collection and filter  
layer at the bottom of  
the quarry.  
(Northwest)

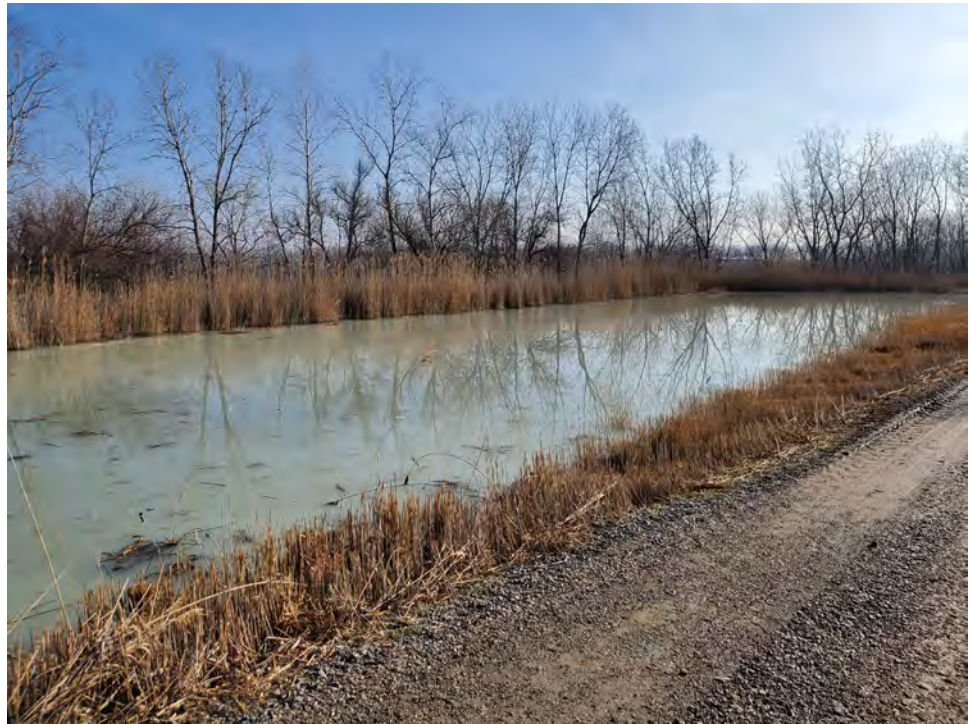
Photograph 20

Date: 4/5/2022

Comments: South upper pond outlet to conveyance channel. (West)

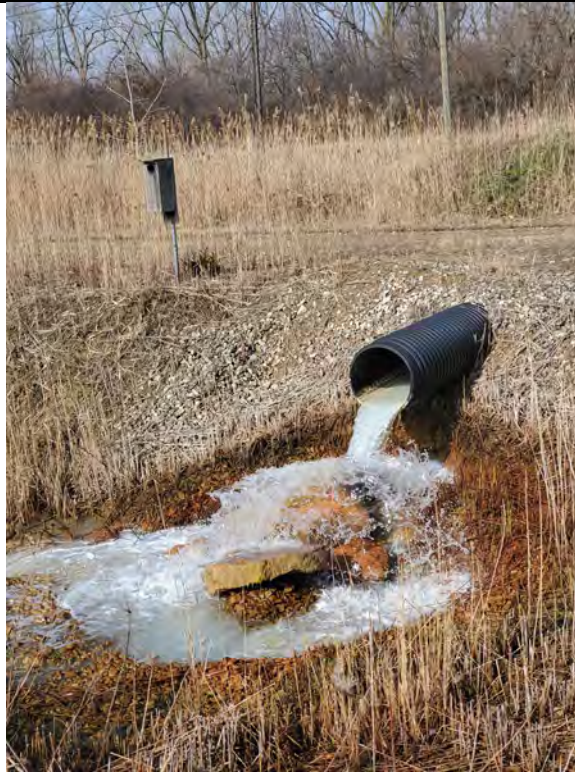
Photograph 24

Date: 4/5/2022

Comments: Culvert connecting Settling Pond #4 to Settling Pond #3. (West)

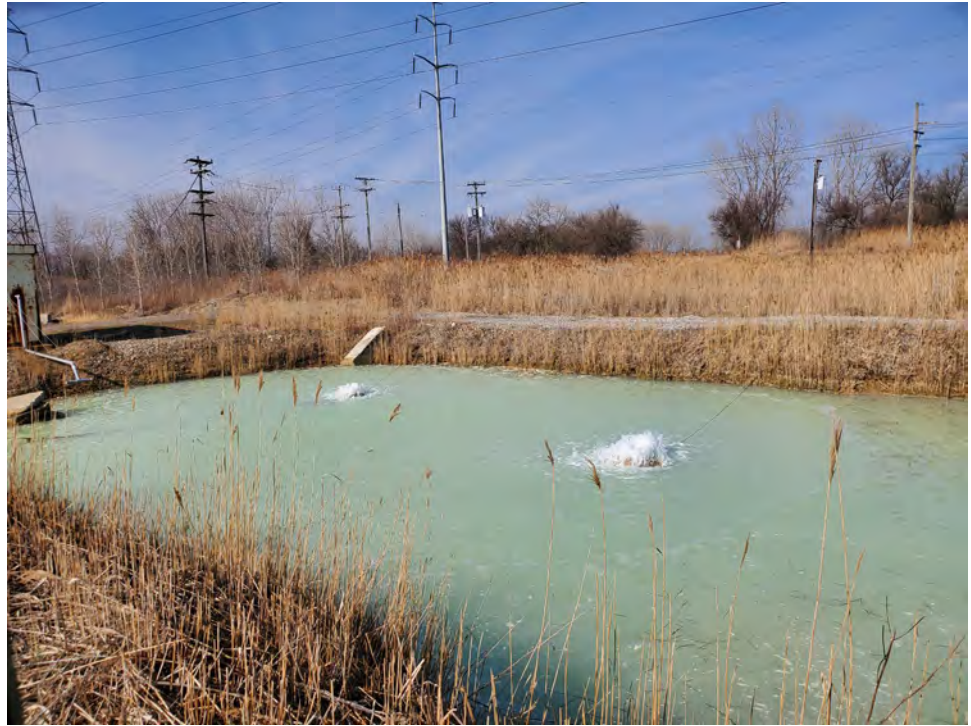
Photograph 26

Date: 4/5/2022

Comments: Settling  
Pond #1. (North)

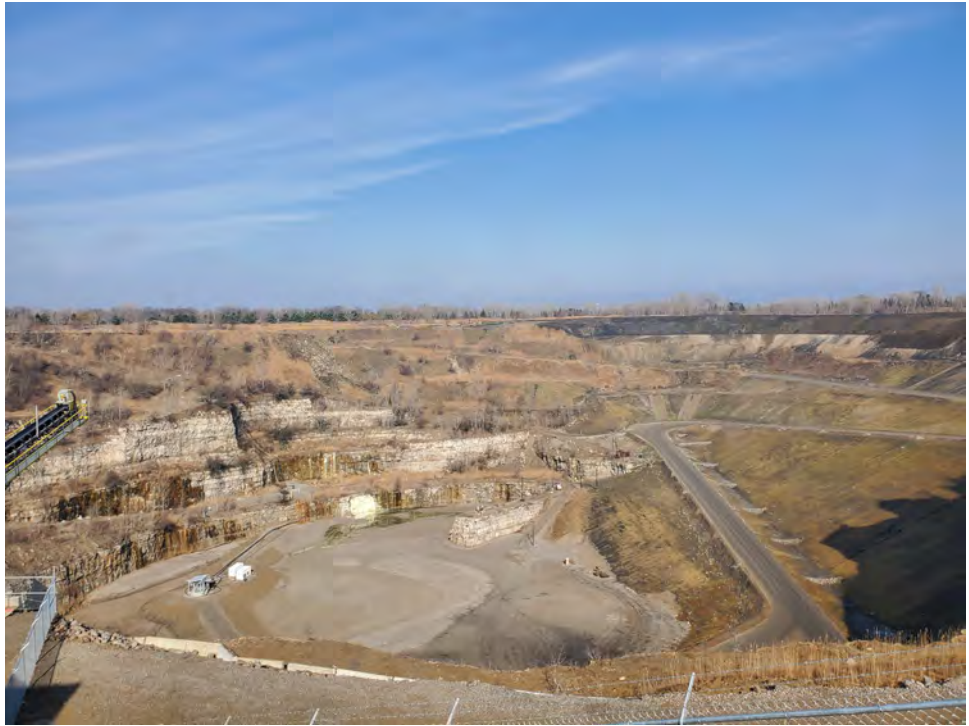
Photograph 28

Date: 4/5/2022

Comments: Ash  
conveyor system that  
may be used to  
bottom ash to the  
bottom of the quarry.  
(West)
