2018 Annual Groundwater Monitoring Report

DTE Electric Company
Range Road Coal Combustion Residual Landfill

3600 Range Road
China Township, Michigan

January 2019

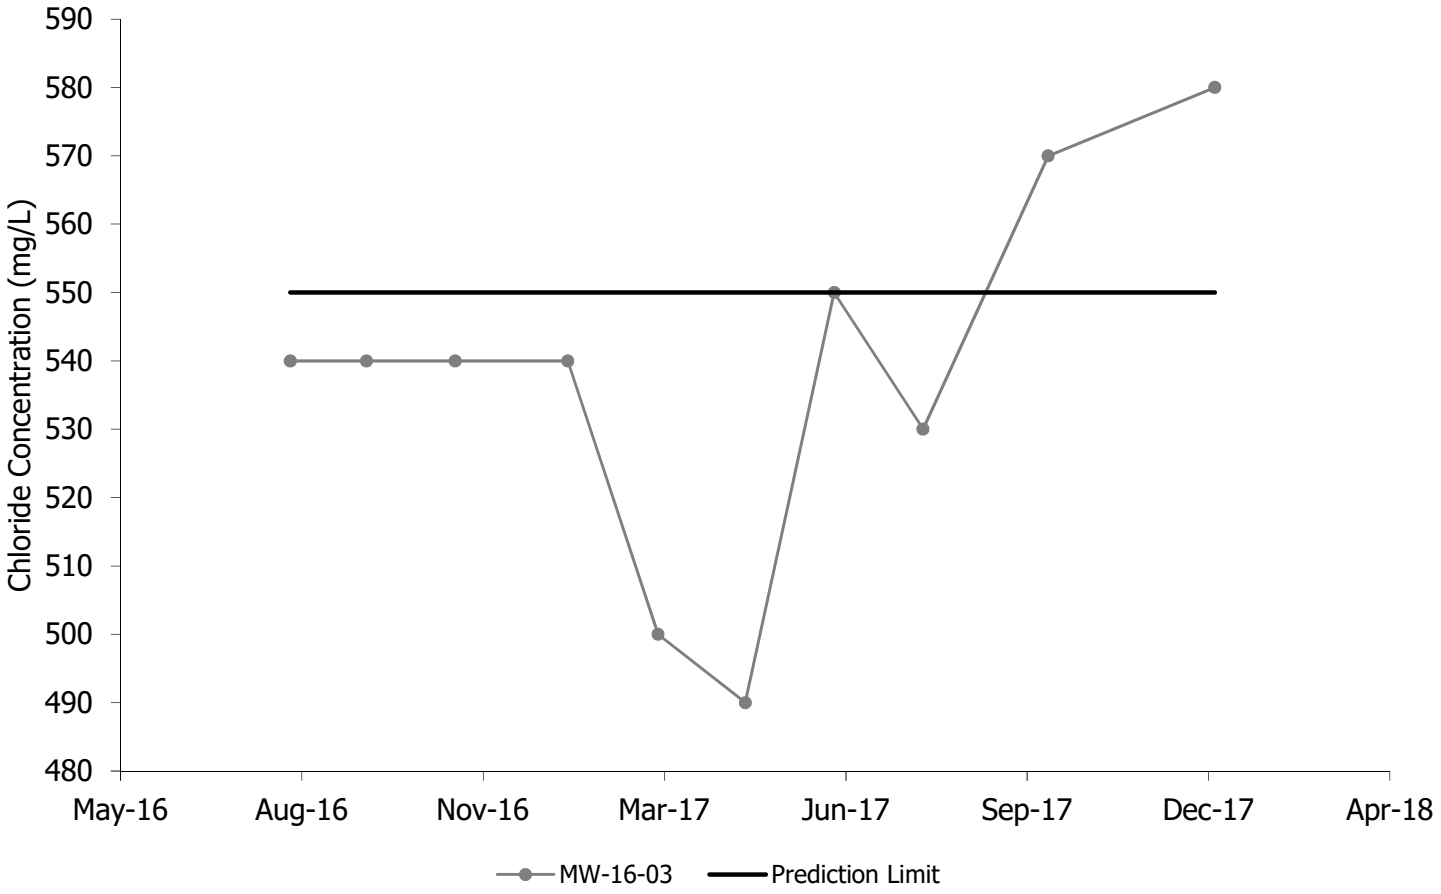
FIGURE 3
MW-16-03 Chloride Time Series Plot

- **Similar increasing trends observed in all site wells** – All site wells reported higher chloride concentration in April 2017 suggesting laboratory variability. As a result of differing prediction limits calculated for each well in the intrawell statistical analysis, this observed increase only resulted in confirmed SSIs in MW-16-03 and MW-16-07.

- **Spatial variability in groundwater quality** – After 8 background sampling events, the prediction limits calculated for each of the 7 monitoring wells range from 330 mg/L to 3,600 mg/L. This variability in groundwater quality across the site provides evidence that the CCR unit is not the source of the confirmed chloride SSIs at MW-16-03 and MW-16-07, but rather the result of regional variability. Similar fluctuations in chloride concentration (Table 1) on a more regional scale were found in the previously mentioned 2007 private drinking water sampling study (RMT, November 2008).

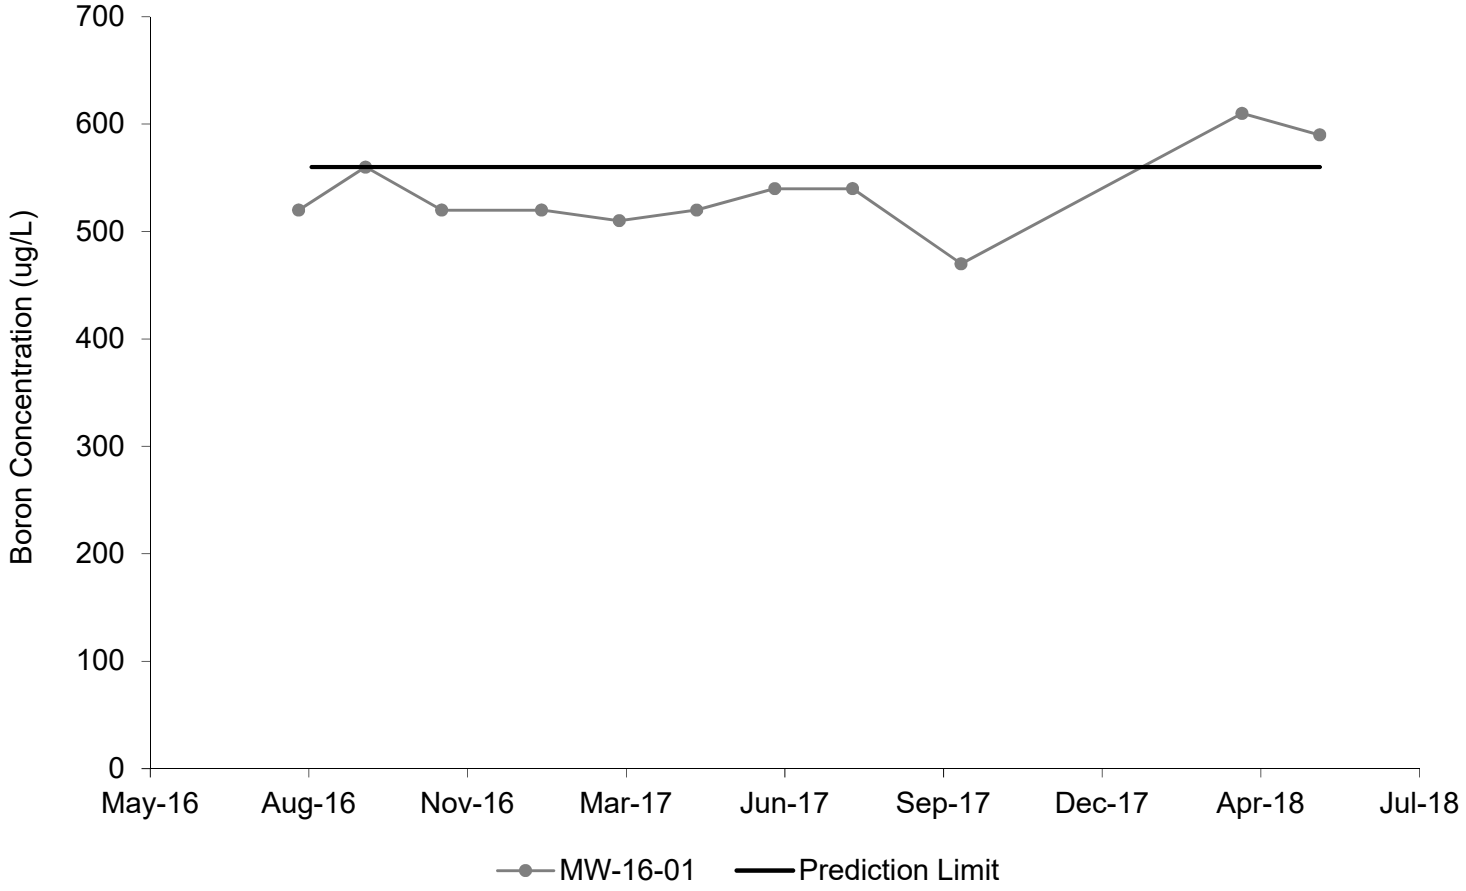
Chart 1
MW-16-01 Boron Time Series Plot
Range Road Landfill – RCRA CCR Monitoring Program

- **Spatial variability in groundwater quality** – After 8 background sampling events, the prediction limit calculated for each of the 7 monitoring wells range from 560 micrograms per liter (µg/L) to 1,200 µg/L. This variability in groundwater quality across the site provides evidence that the CCR unit is not the source of the confirmed boron SSI at MW-16-01, but rather the result of regional variability. Similar fluctuations in boron concentration (Table 1) on a more regional scale were found in the previously mentioned 2007 private drinking water sampling study (RMT, November 2008).

- **Insufficient background sampling timeline to account for long-term trends** – Variability in boron concentrations observed in the groundwater at RRLF during the background sampling events provides evidence of the heterogeneity of this constituent in groundwater. The short duration of the background sampling events limits the ability of the statistical analysis to capture the natural temporal trends in the groundwater quality at the RRLF. This is a limitation of the CCR Rule implementation timeline.

- **Lack of similar or proportional increase in other indicator parameters** – Boron and chloride have similar mobility in groundwater. In the event of a CCR leachate release, SSIs for chloride and boron would typically occur at the same time. The lack of chloride SSIs at the majority of monitoring wells and not present within the same monitoring well suggests a source other than CCR leachate for the observed boron SSI at this location.

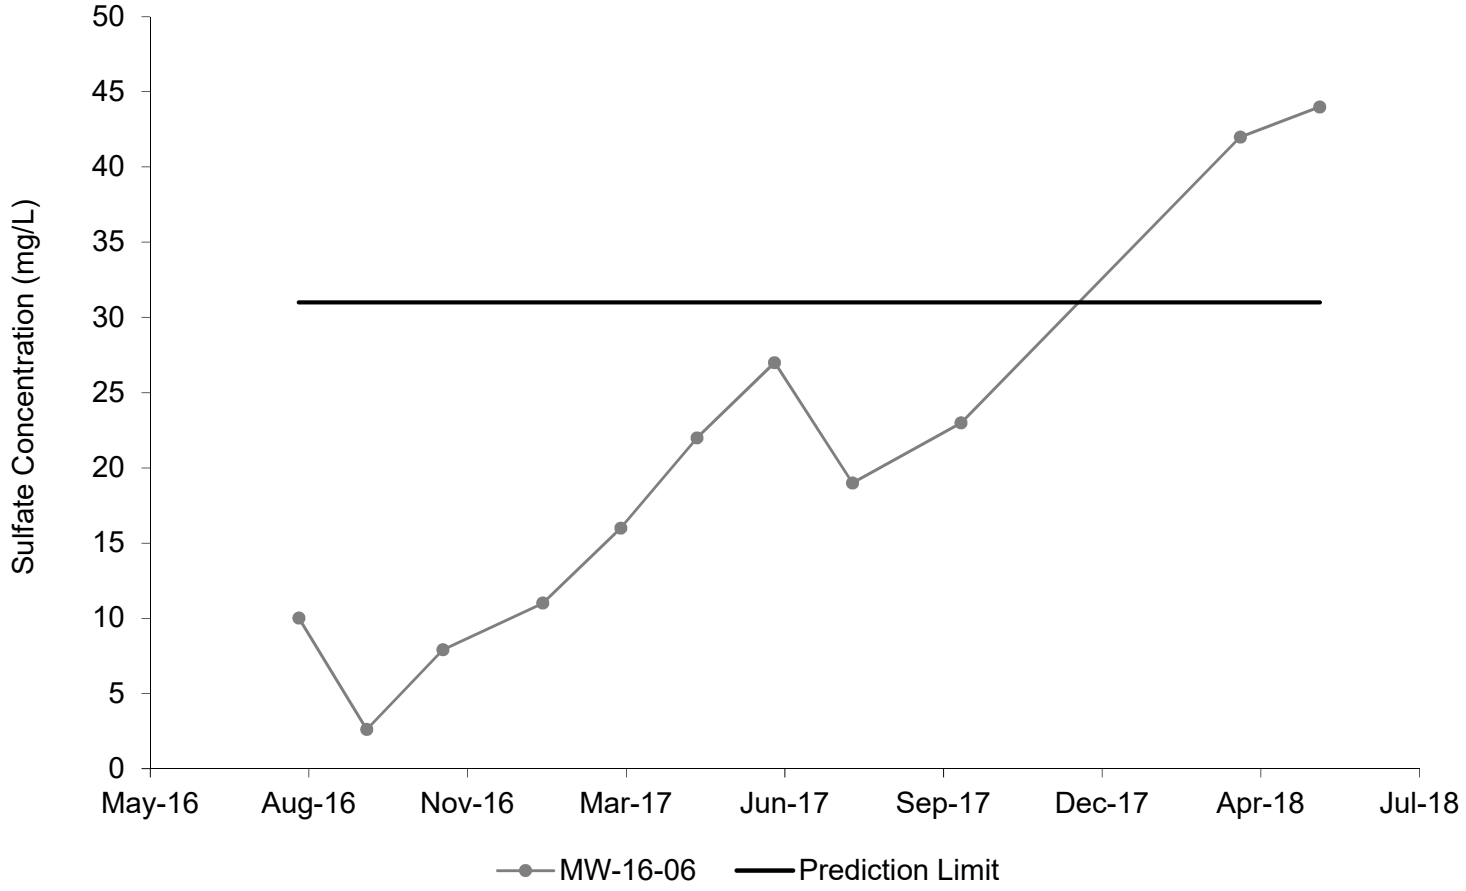
Chart 2
MW-16-06 Sulfate Time Series Plot
Range Road Landfill – RCRA CCR Monitoring Program

- **Insufficient background sampling timeline to account for long-term trends** – Variability in sulfate concentrations observed in the groundwater at RRLF during the background sampling events provides evidence of the heterogeneity of this constituent in groundwater. The short duration of the background sampling events limits the ability of the statistical analysis to capture the natural temporal trends in the groundwater quality at the RRLF. This is a limitation of the CCR Rule implementation timeline.

- **Lack of similar increase in other indicator parameters** – The lack of SSIs for any other parameters within the same monitoring well, and across the other wells within the monitoring well network, also suggests a source other than CCR leachate for the observed sulfate SSI at this location.
