Submitted to
DTE Electric Company

Submitted by
AECOM
1300 East 9th Street, Suite 500
Cleveland, OH 44114
August 2019

CCR Certification:
Structural Stability Assessment
Inactive Bottom Ash Impoundment
DTE Monroe Power Plant

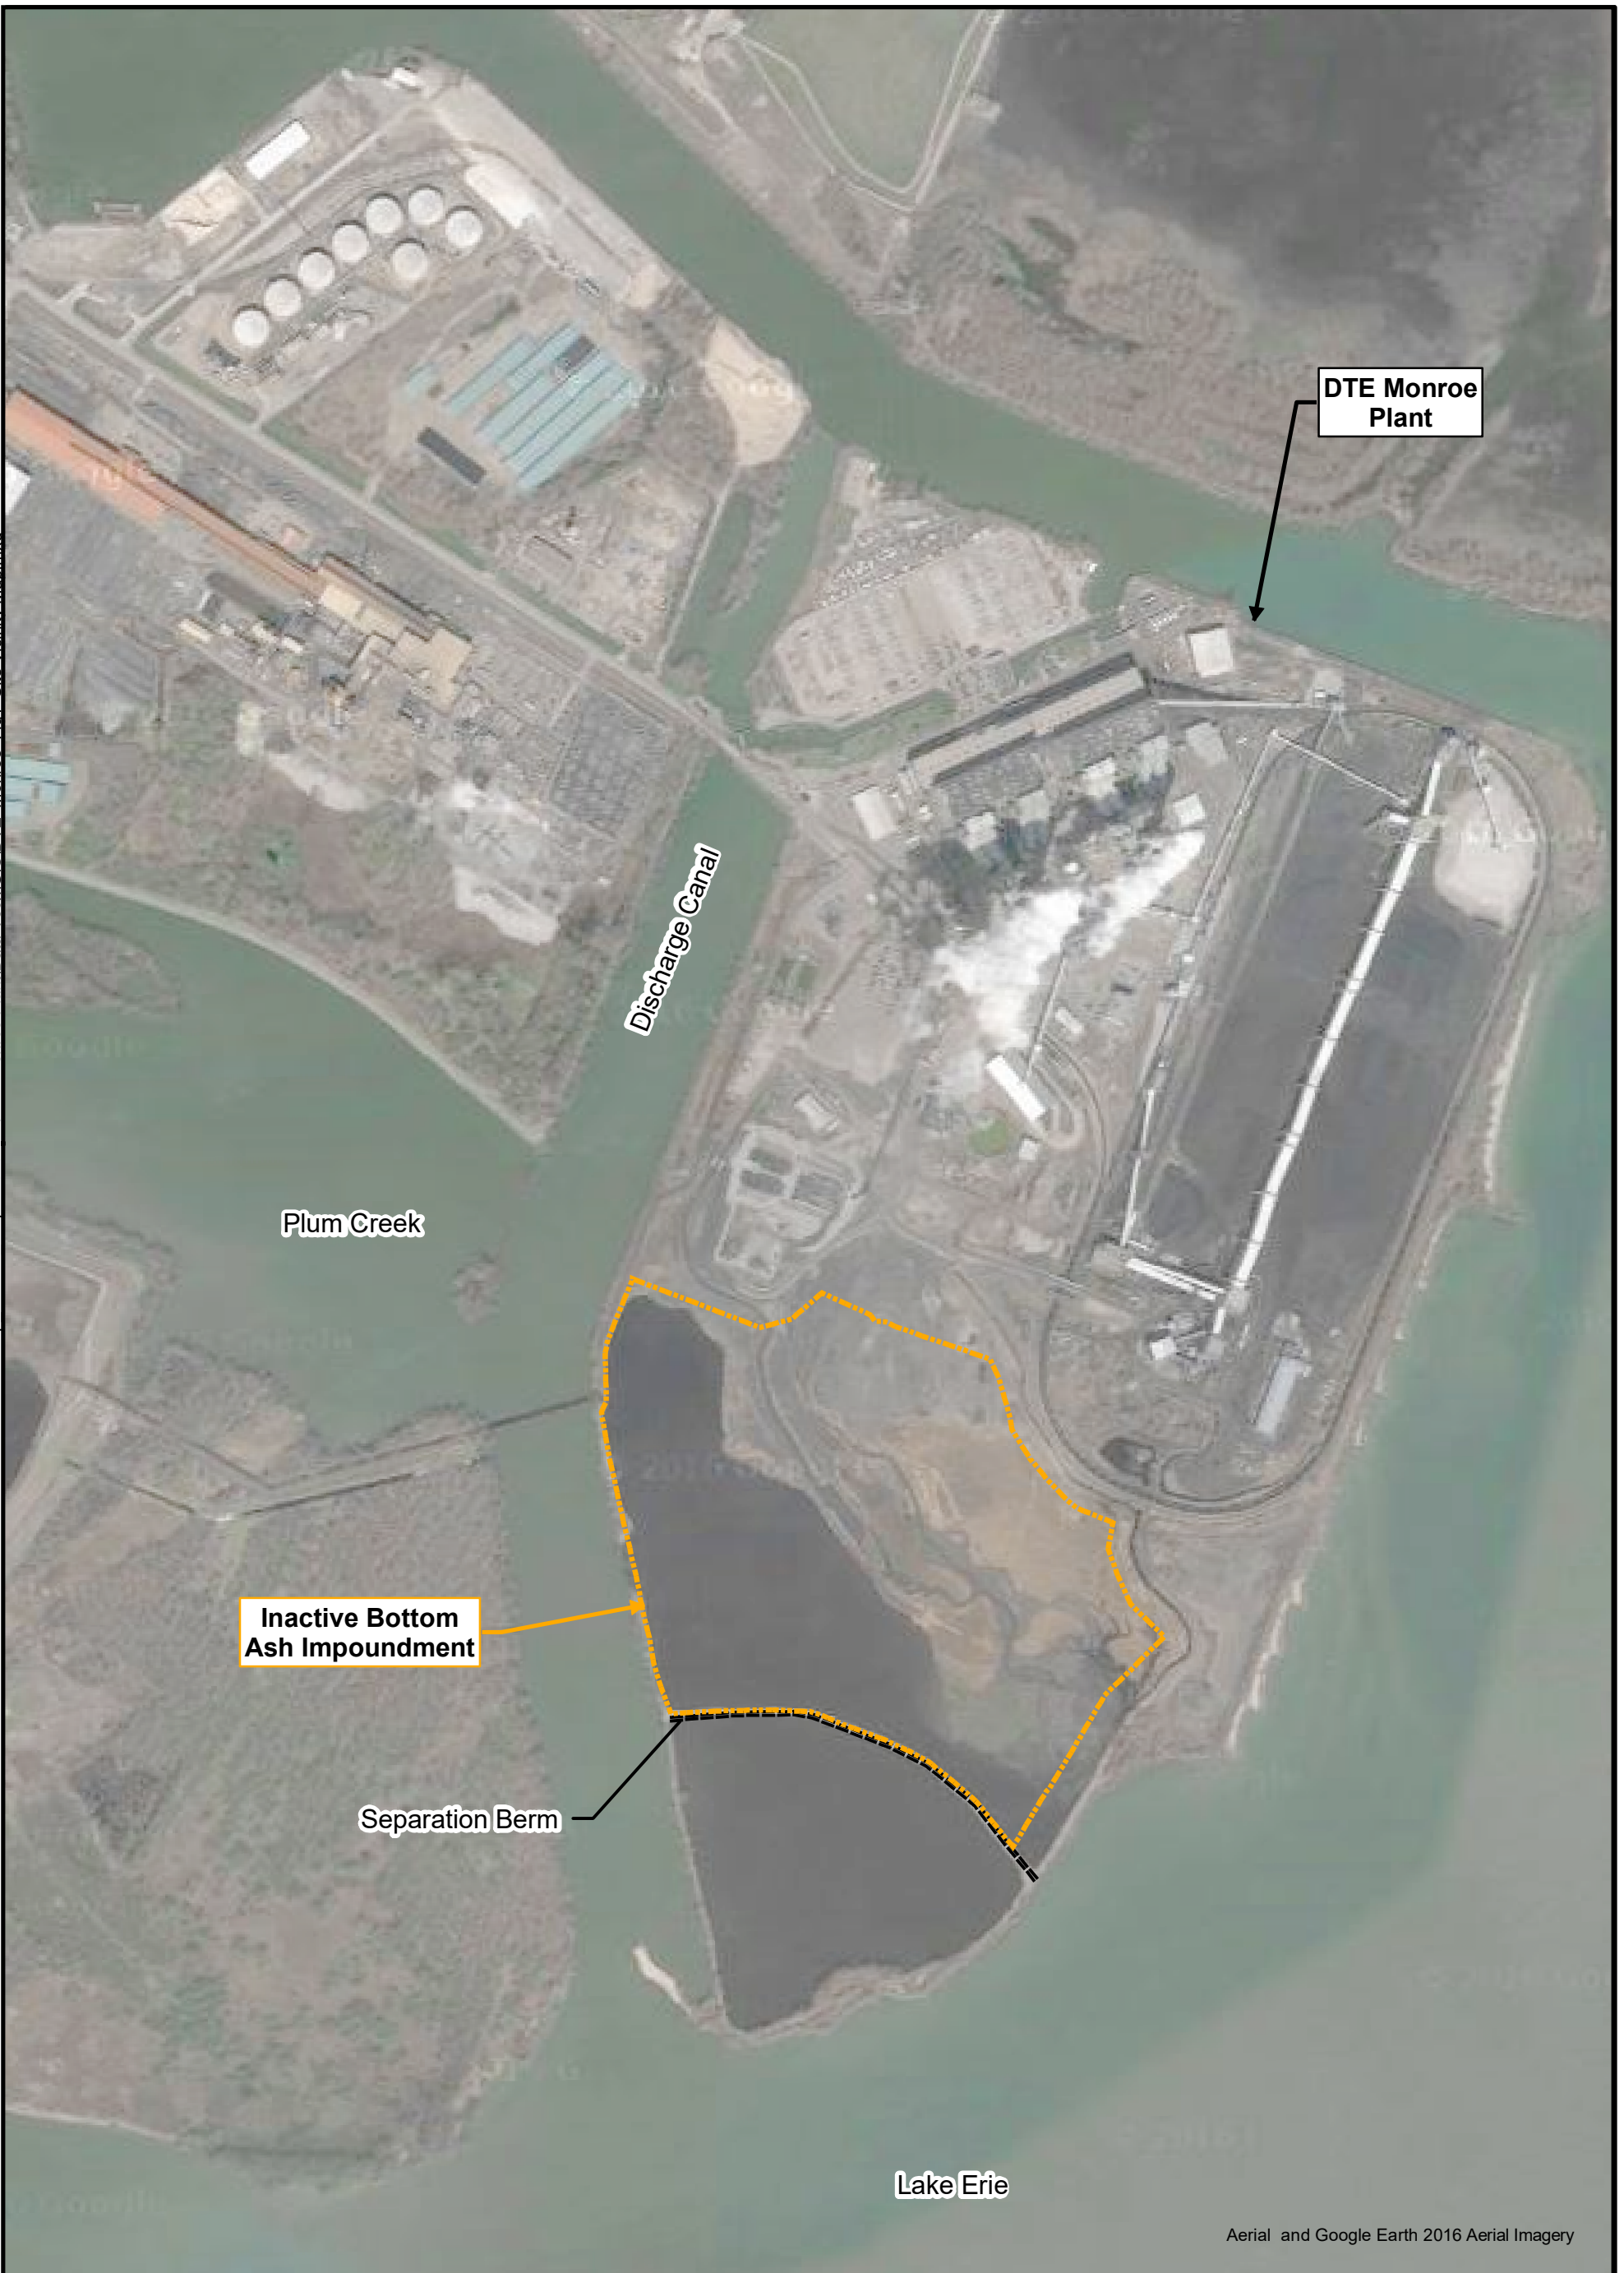
LEGEND:	
Unit Separation Berm	
Approximate Boundary of Inactive Bottom Ash Impoundment	
Monroe Power Plant	
FIGURE 2 AERIAL SITE MAP	
DATE: 8/13/2019	SCALE 1 inch = 700 feet
JOB NO. 60516675

The Inactive Bottom Ash Impoundment is located to the south of the main Monroe Plant area and encompasses an area approximately 86.4 acres in size. The Inactive Bottom Ash Impoundment area was constructed in the late 1960s by building a perimeter dike to surround a low area of the adjacent Lake Erie. The area south of the plant was removed from the Waters of the United States by an Act of Congress prior to plant construction. CCR materials have been placed and allowed to drain into the impoundment from the north, and currently form a delta that extends about 1/3 of the way into the impoundment. Appendix A provides a Site Location Map showing the general location of the project site (**Figure 1**) and an Aerial Site Map of the Inactive Bottom Ash Impoundment (**Figure 2**).
