**2017 ANNUAL INSPECTION REPORT  
RANGE ROAD LANDFILL  
ASH DISPOSAL FACILITY**

**China Township, St. Clair County, Michigan**

January 2018

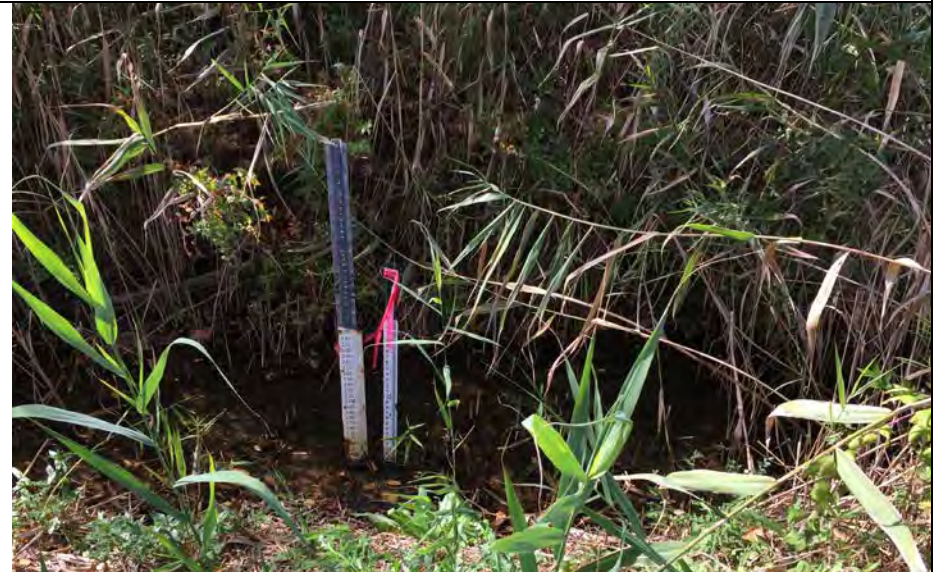
52. Perimeter Ditch Monitoring Staff Gauge SG-03. No visible Flow.

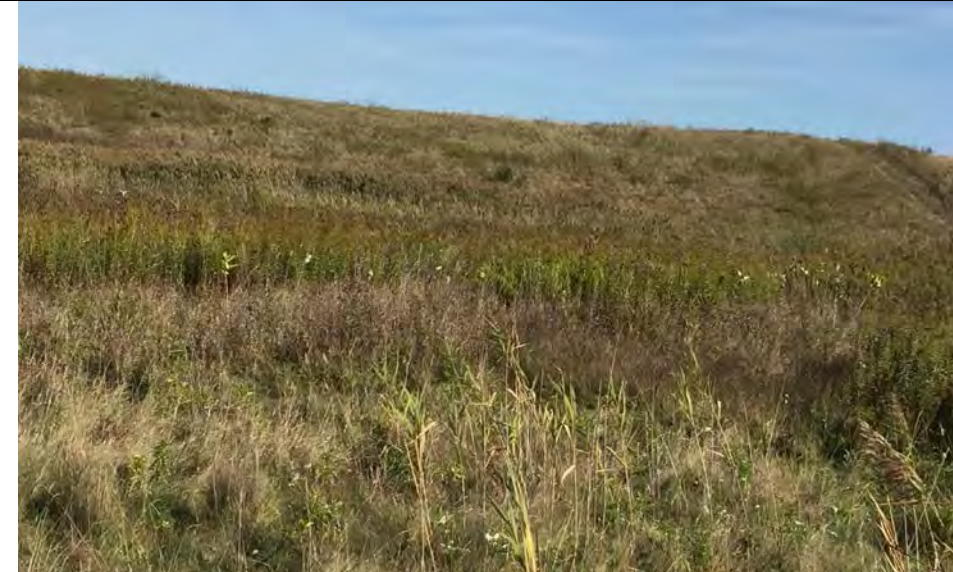
71. Looking East at Vegetated Slope of Closed Area F2.

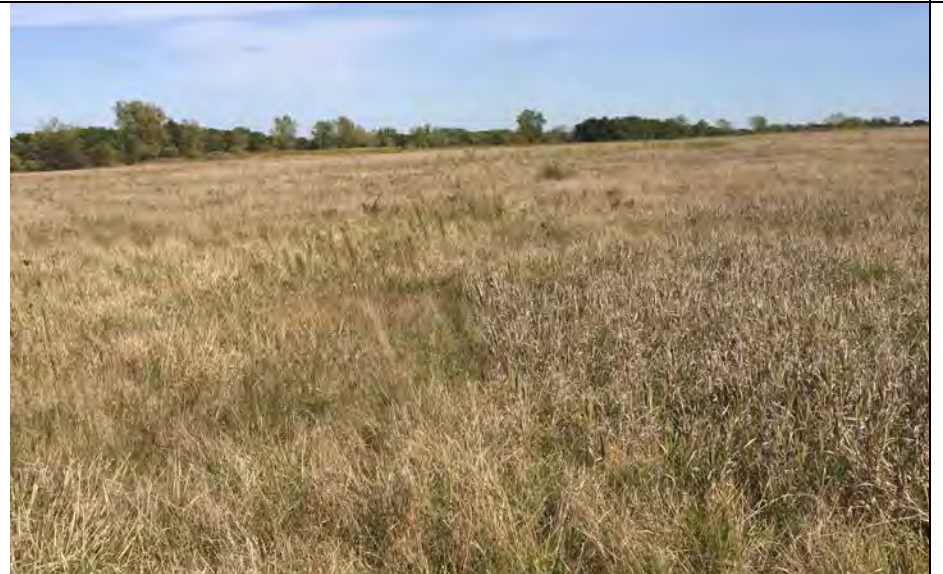
76. View Looking North of Typical Top of Closed Landfill Areas.

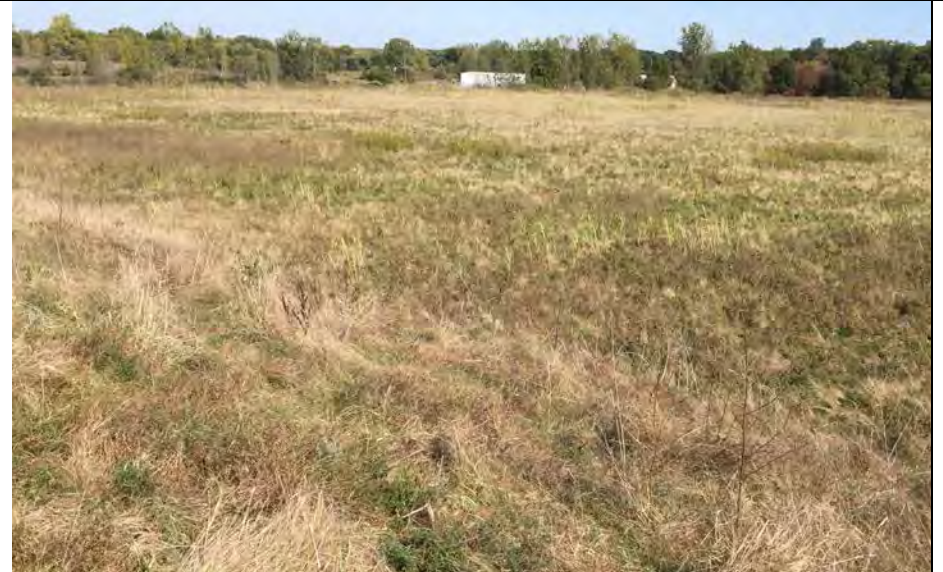
80. Another View of Typical Top of Closed Landfill Areas.
